Cooper & Withycombe

**The Harlington
236 Fleet Road
Fleet
Hampshire
GU51 4BY**

Condition Survey Report

January 2020

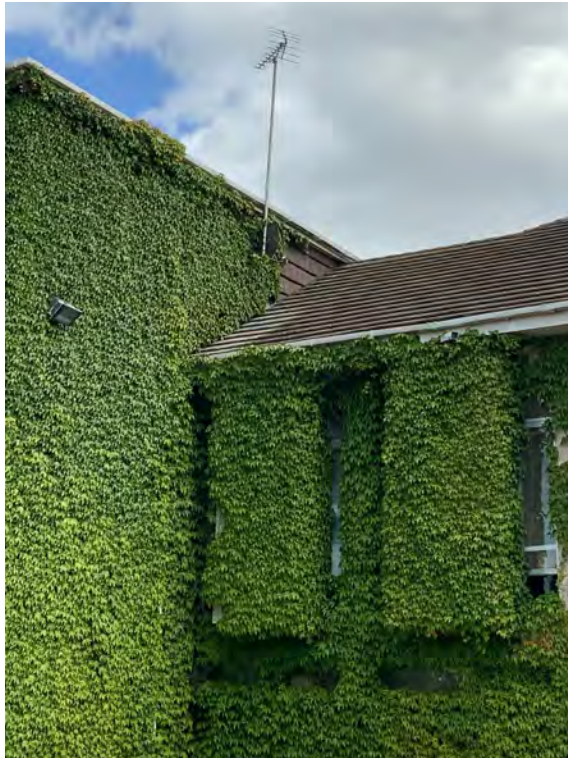
P4 Roof above Town Council Offices and main hall

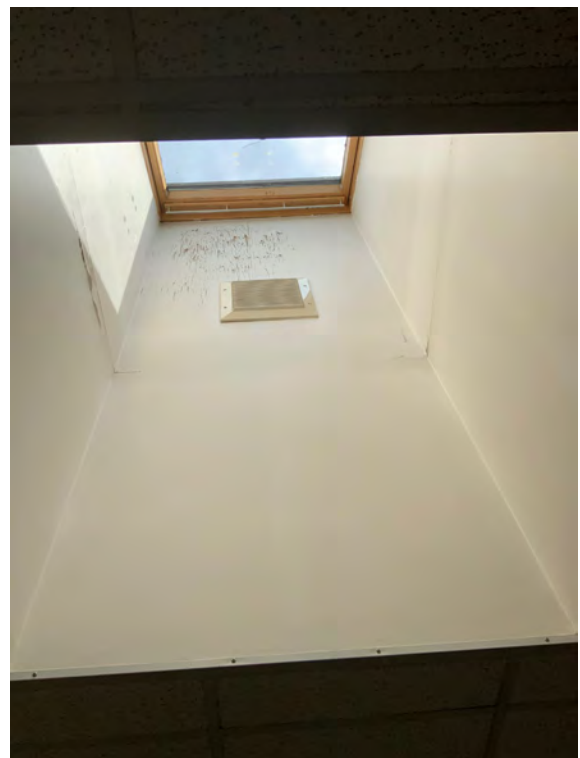
P31 Ceiling to auditorium

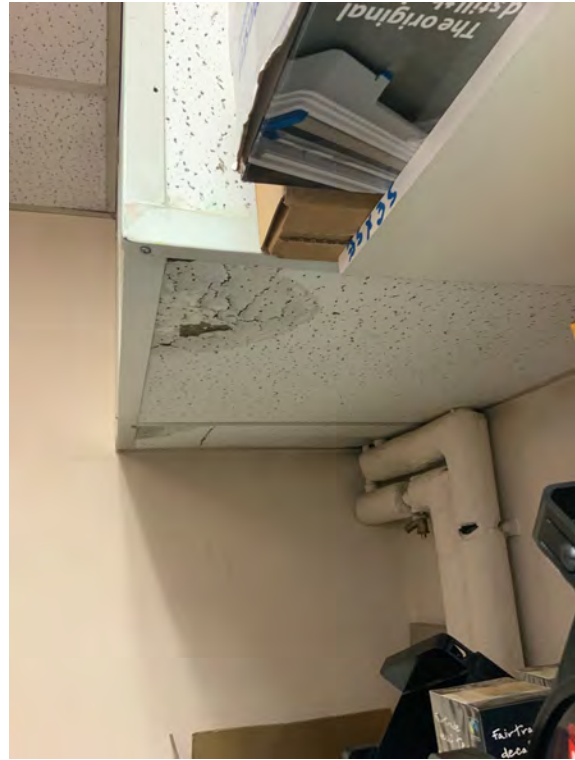
P37 Store Room adjacent RVS – L shaped crack around ceiling board

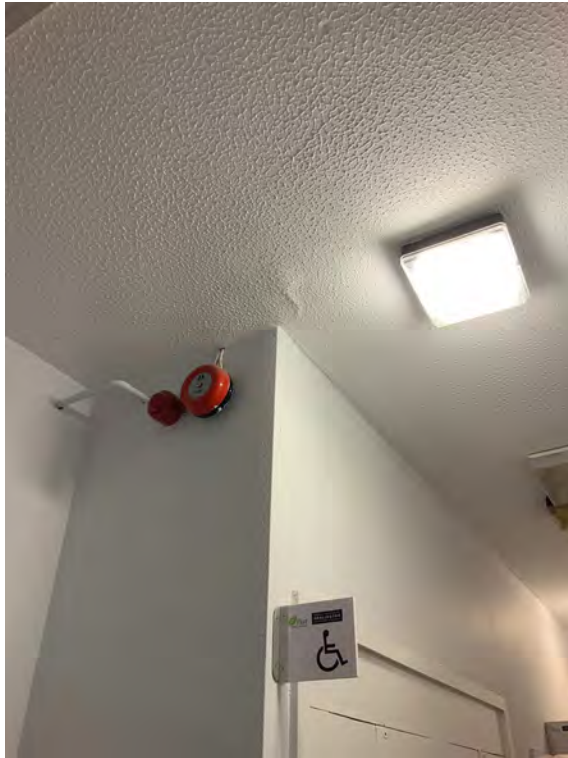
P49 First Floor, Ladies Toilet – Ceiling structure.

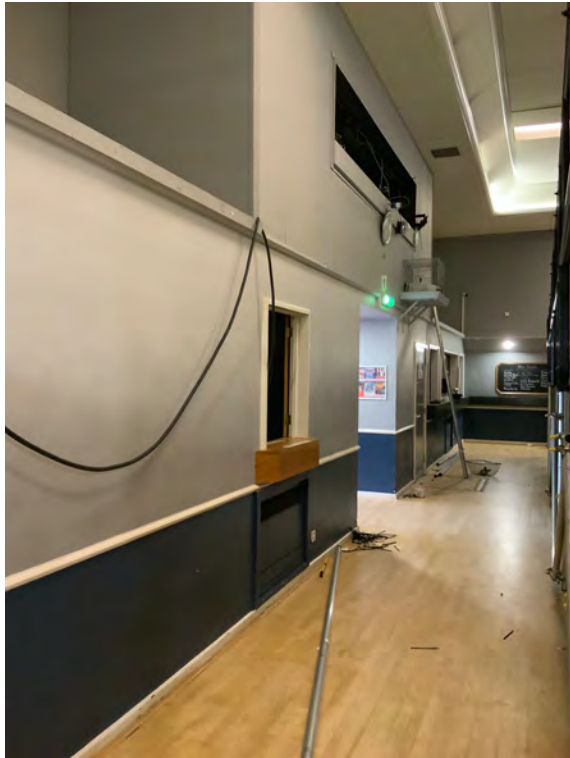
P61 Stage Store – Missing area of ceiling
due to drainage

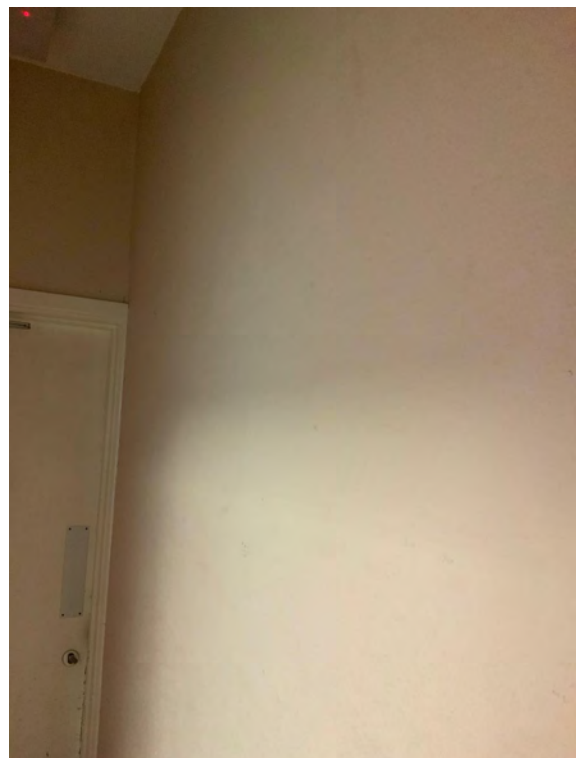
P64 RVS – Area between upper and lower dining rooms, including trellis.

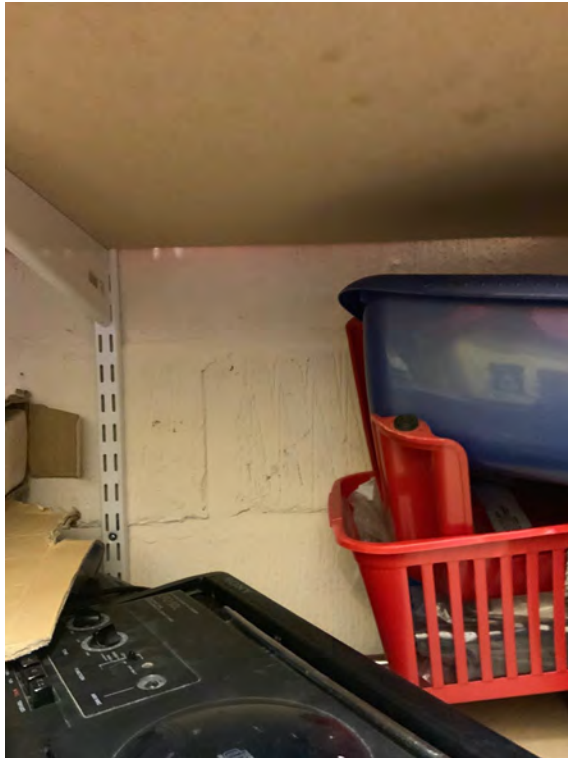
P89 Control Room – Structure behind.

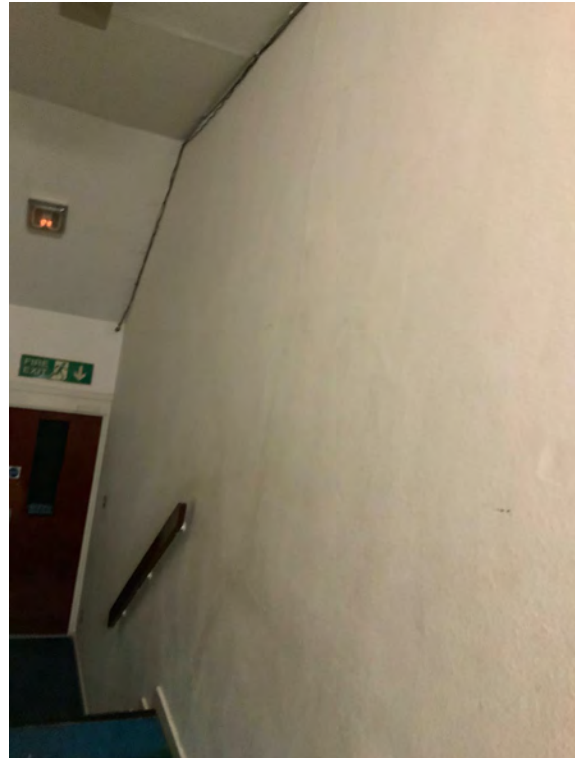
P99 Dressing Room Corridor Rear Stairs –
Impact damage leading to basement

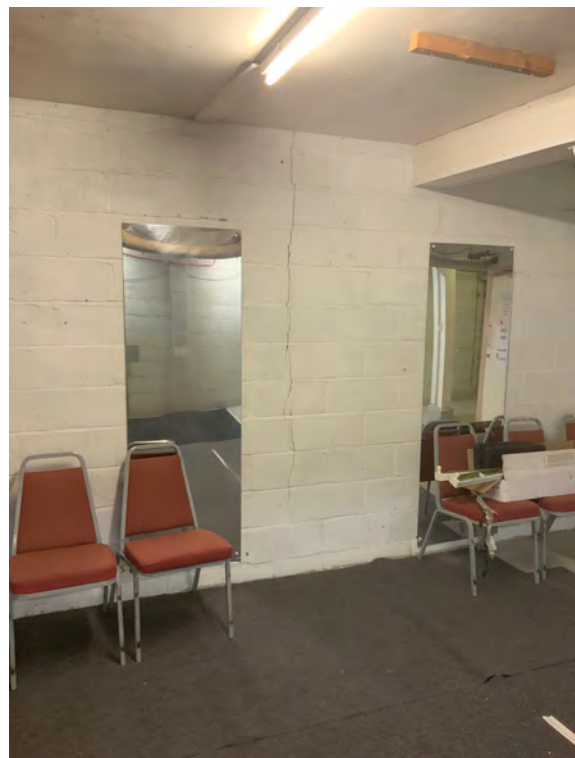
P113 Basement Stage Store – Supporting piers.

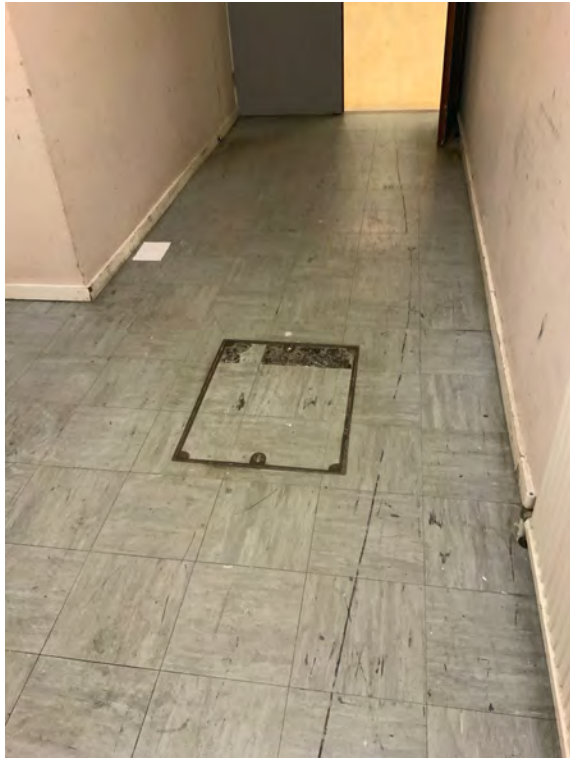
P118 RVS Accessible Toilet – Manhole set
into toilet floor

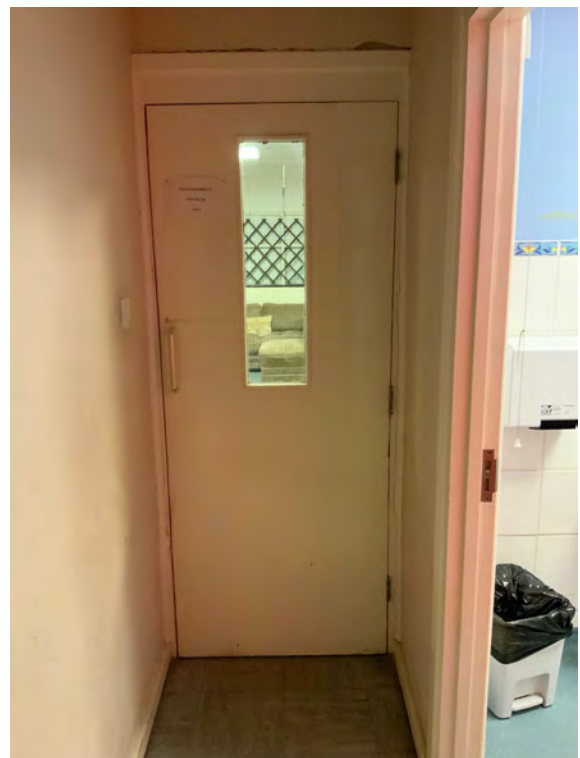
P145 Door set to Dance Studio

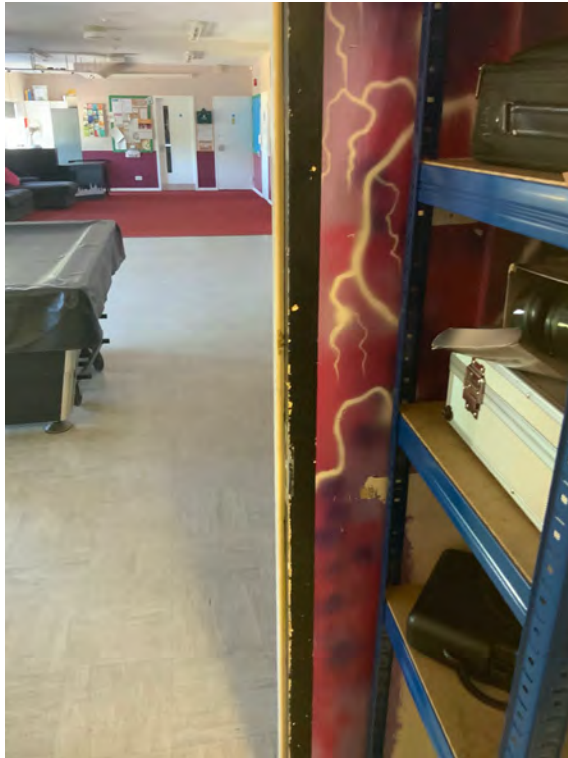
P150 First Floor Store – Cracking around door frame
