The Harlington Asbestos Register and Site Plans

**Register covers locations with identified or strongly presumed
asbestos containing materials**

Last reviewed March 2025

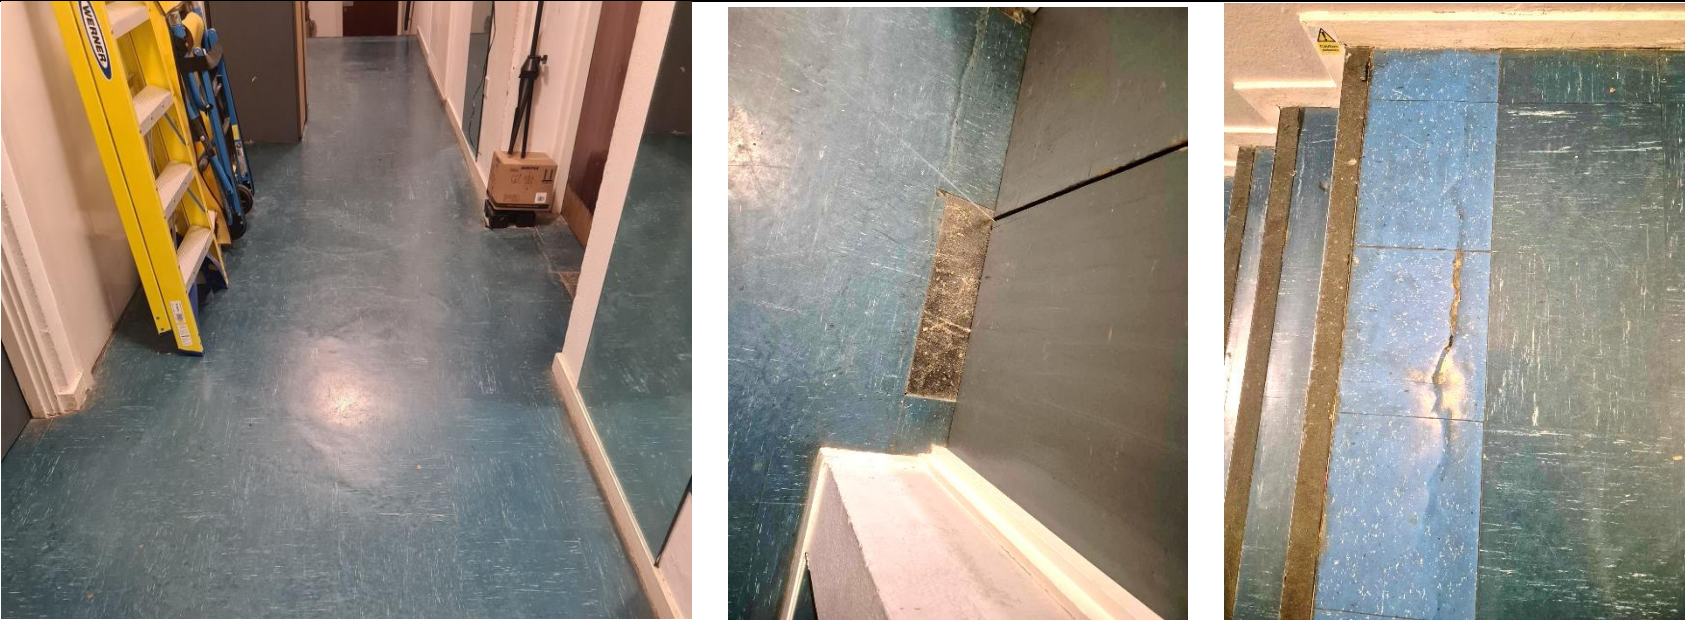
Plan No. and Location	Product / Asbestos Type	Extent	Condition	Surface Treatment	Sampled / Presumed	Material Score <i>fiber release</i>	Priority Score <i>disturbance</i>	Risk Total	Action & Due Date	Action Comment	Other Comments
1 - Backstage corridor, both backstage changing rooms and stairs to basement HDC 033	BITUMEN floor tile adhesive & blue VINYL floor tiles	32m ²	Minor damage - cracked top step and one missing tile under stage door	Sealed	Previous Sample	3	4	7	Encapsulate damage by 30/06/25 & monitor	Last Checked March 2025	-

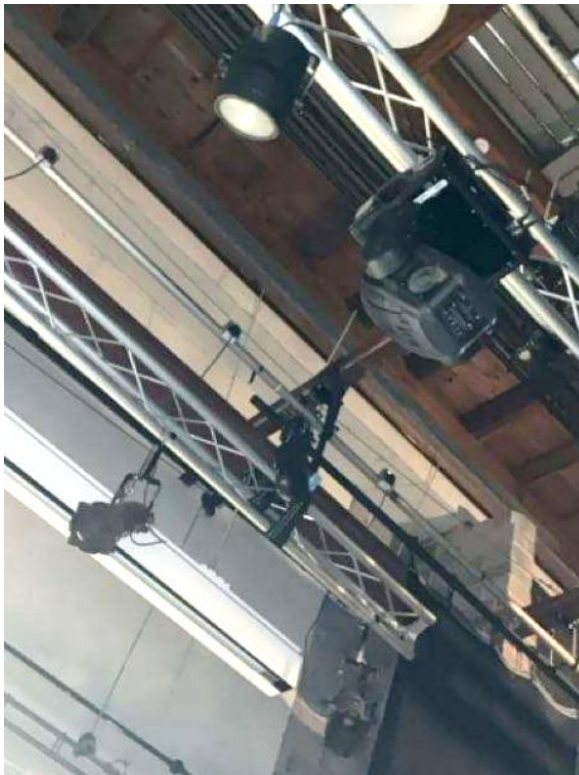
BEAM CASING

<p style="text-align: right;">BACKSTAGE FLOOR</p>											
2 - Stage: High level white boxed casing – top of wall HDC 012	High level casing INSULATING BOARD	16m ²	Good	Painted	Strongly Presumed	9	4	13	Checked every August	Last Checked Aug 2024	-

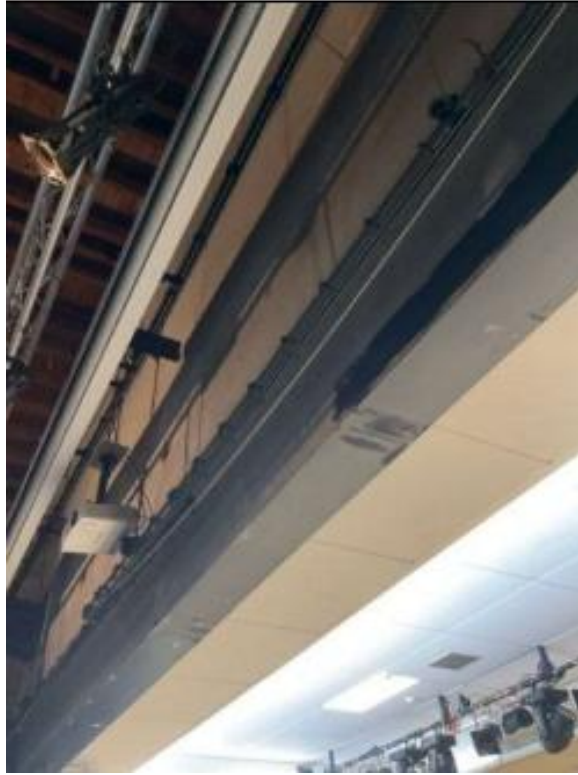
VERTICAL PANELS

Plan No. and Location	Product / Asbestos Type	Extent	Condition	Surface Treatment	Sampled / Presumed	Material Score <i>fiber release</i>	Priority Score <i>disturbance</i>	Risk Total	Action & Due Date	Action Comment	Other Comments
2 - Stage: Vertical panels to beam to stage opening HDC 012	Vertical panels to beam INSULATING BOARD	12m ²	Minor damage - area of paint chipped away	Painted	Previous Sample	8	5	13	Encapsulate damage by 30/06/25 & monitor	Last Checked Aug 2024	-

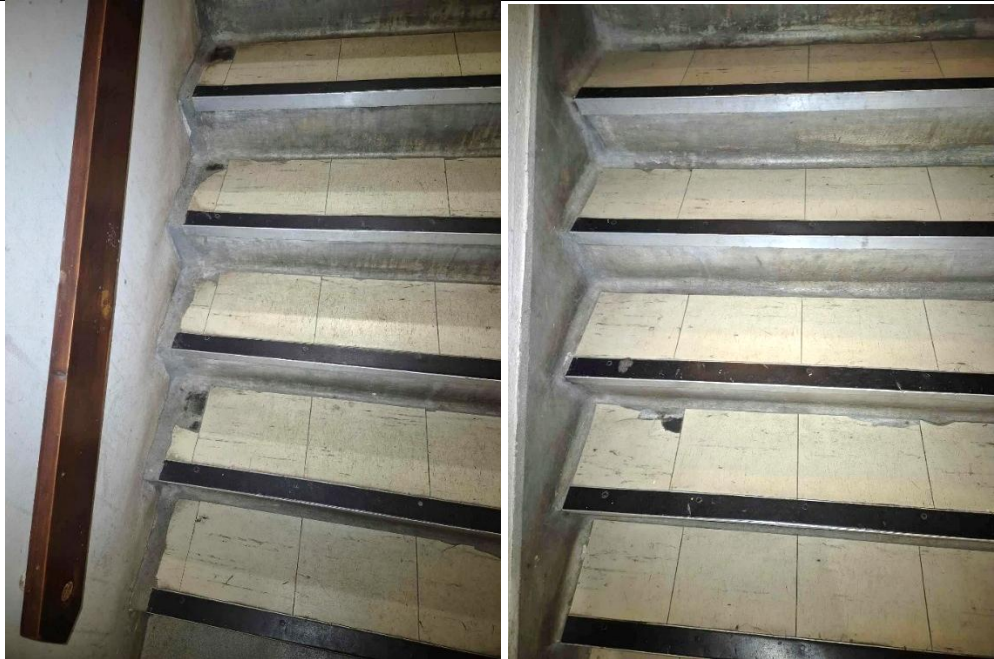
KITCHEN STAIRS – bottom (right) top (left)

Plan No. and Location	Product / Asbestos Type	Extent	Condition	Surface Treatment	Sampled / Presumed	Material Score <i>fiber release</i>	Priority Score <i>disturbance</i>	Risk Total	Action & Due Date	Action Comment	Other Comments
3 - Main Kitchen stairs leading to 2nd Floor HDC 020	BITUMEN floor tile adhesive & white VINYL floor tiles	10m ²	Minor damage – some sections of tiles missing	Sealed	Previous Sample	2	4	6	Encapsulate damage by 30/06/25 & monitor	Last Checked March 2025	-

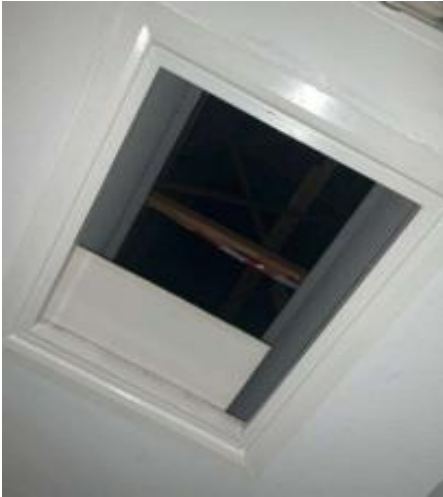
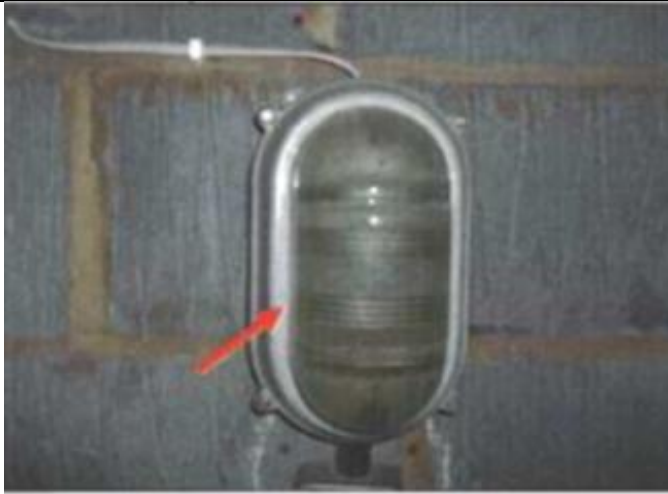
4 – Loft: sealant around light fitting. The loft area accessed via the hatch above the General Managers Office	Light fitting sealant	-	Good	None	Previous Sample	4	4	8	Checked every August	Last Checked Aug 2024	-
---	-----------------------	---	------	------	-----------------	---	---	---	----------------------	-----------------------	---

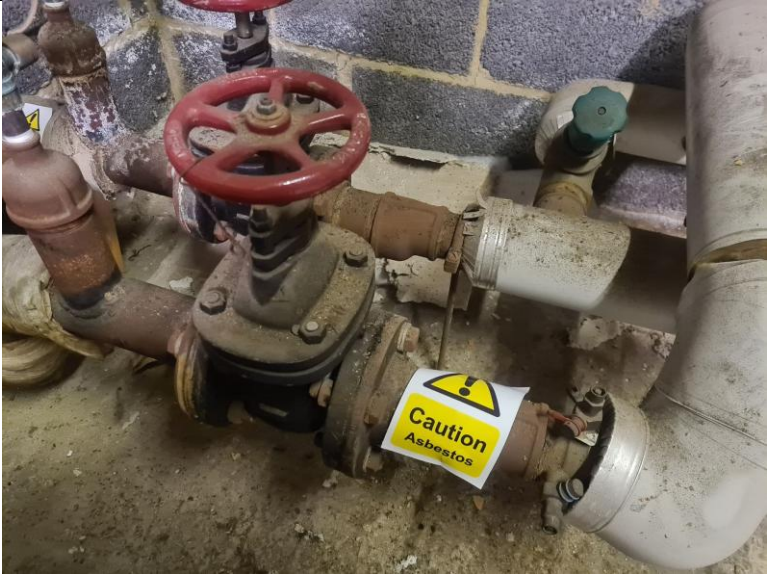
<p style="text-align: center;">GM OFFICE LOFT HATCH FITTING</p>									
<p>5 - Plant Room i.e. the main loft area, on right hand side of space once you reach top of access ladder. Accessed via ladder in storeroom behind dance studio. HDC 075</p>	<p>GASKETS <i>compressed</i> on pipe flanges</p>	<p>-</p>	<p>Good</p>	<p>None</p>	<p>Previous Sample</p>	<p>2</p>	<p>2</p>	<p>4</p>	<p>Checked every August</p>	<p>Last Checked Aug 2024</p>	<p>-</p>

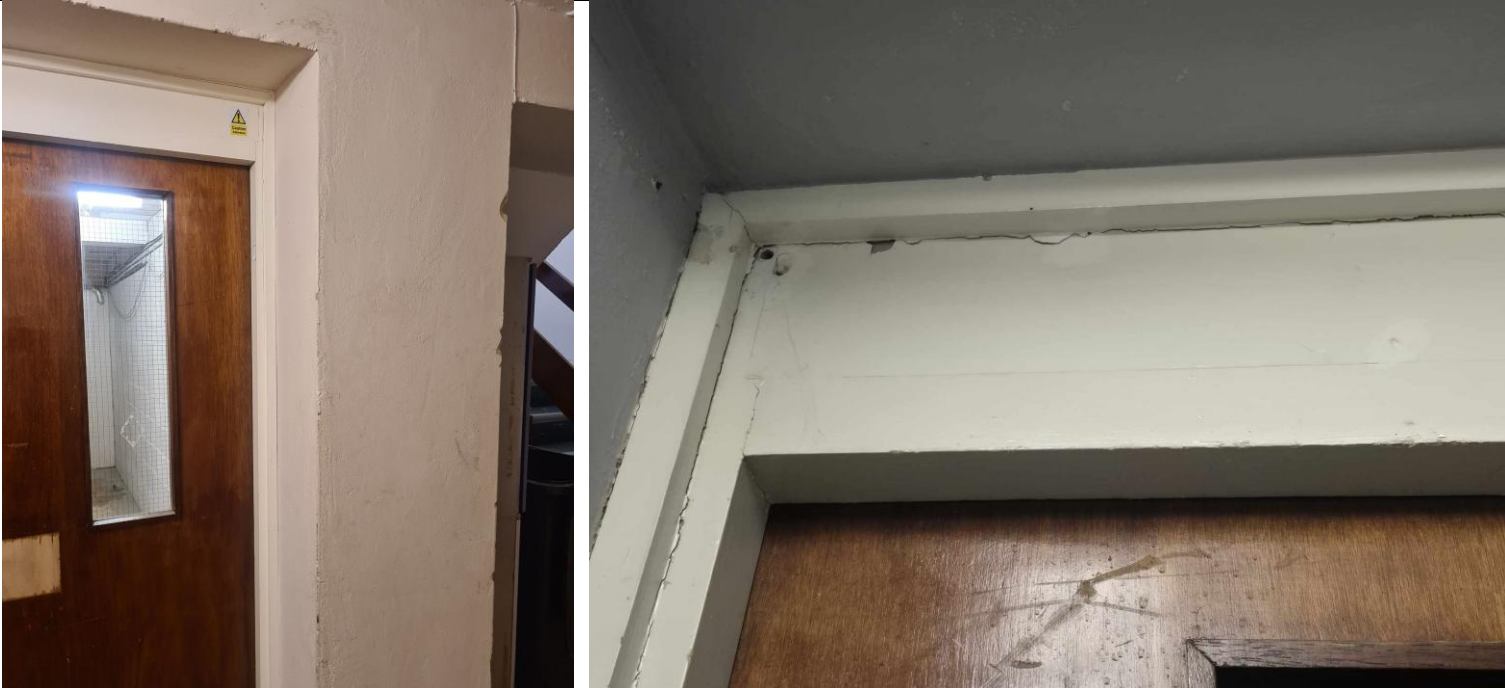
PLANT ROOM GASKET											
6 – Basement above double doors leading into under stage via back stage corridor stairs HDC 069 + 073	Paneling above door frame INSULATING BOARD	-	Minor damage – paint chipped	Painted	Previous Sample	7	4	11	Encapsulate damage & monitor by 30/06/25	Last Checked March 2025	-

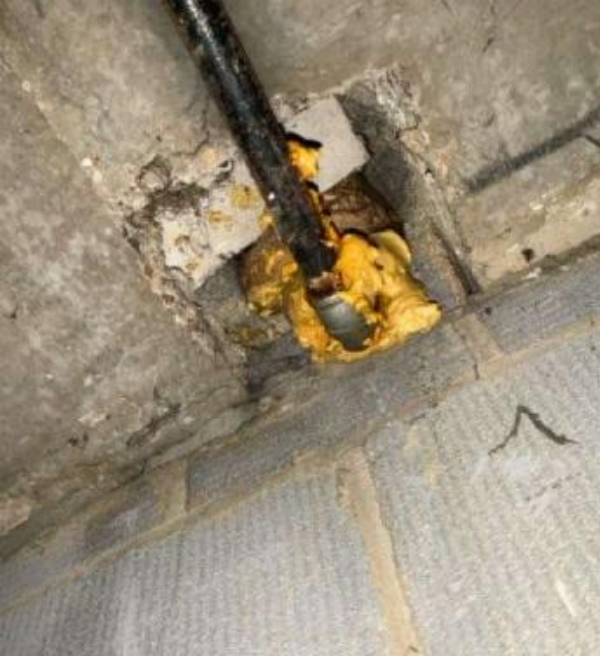
BASEMENT DOOR											
7 - Outside store i.e. 'market traders' - as you walk into store, about halfway across back wall where wall meets ceiling HDC 064	Pipe Duct - Panel within pipe exit to ceiling - rear of area INSULATING BOARD	-	Minor damage – wear to panel	None	Previous Sample	8	3	11	Encapsulate damage & monitor by 30/06/25	Last Checked Aug 2024	-

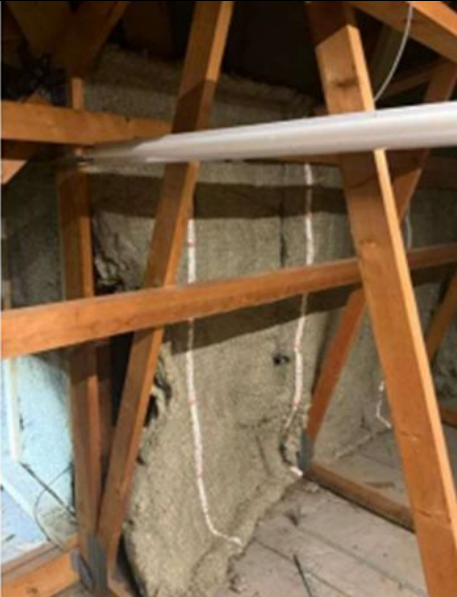
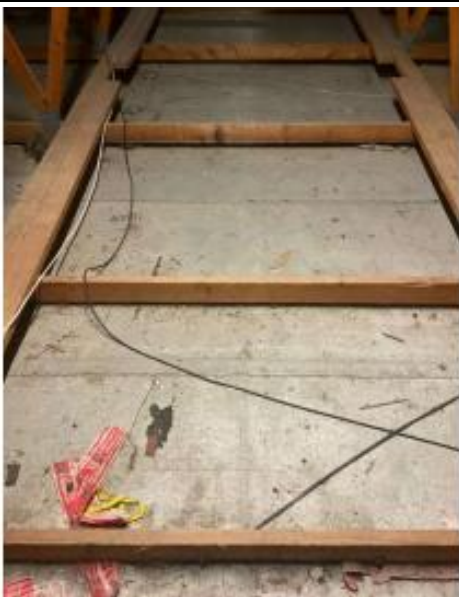
<p>OUTSIDE STORE</p>											
8 - Roof void via right hand door in main loft accessed via ladder in store room behind dance studio. HDC 076	Roof felt – former roof including debris around penetration BITUMEN	150m ²	High risk – felt exposed and debris	None	Previous Sample	5	3	8	Checked every August	Last Checked Aug 2024	To enter voids a P3 respirator mask must be worn

<p>< ROOF FELT IN VOID AREA 8</p> <p>< FLOORING IN VOID AREA 8</p>							
8 - Roof void via right hand door in main loft accessed via ladder in store room behind dance studio. HDC 076	Floor - silver floor covering former roof BITUMEN	150m ²	Minor damage - age	None		3	3	6	Checked every August	Last Checked Aug 2024	To enter voids a P3 respirator mask must be worn
8 - Roof void via right hand door in main loft accessed via ladder in store room behind dance studio. Second void accessed through first void. HDC 077	Roof felt – former roof including debris around penetration BITUMEN	220m ²	High risk – felt exposed and debris	None	Previous Sample	5	3	8	Checked every August	Last Checked Aug 2024	To enter voids a P3 respirator mask must be worn

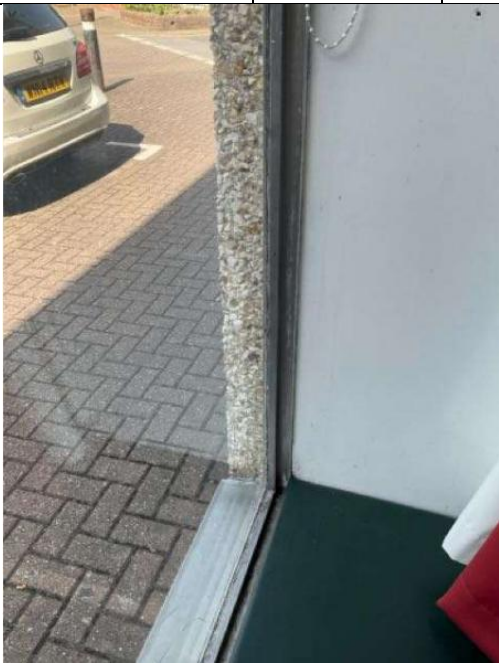
FUNCTION ROOM WINDOWS

Plan No. and Location	Product / Asbestos Type	Extent	Condition	Surface Treatment	Sampled / Presumed	Material Score <i>fiber release</i>	Priority Score <i>disturbance</i>	Risk Total	Action & Due Date	Action Comment	Other Comments
8 - Roof void via right hand door in main loft accessed via ladder in store room behind dance studio. Second void accessed through first void. HDC 077 & 078	Floor - silver floor covering former roof BITUMEN	235m ²	Minor damage - age	None	Previous Sample	3	3	6	Checked every August	Last Checked Aug 2024	To enter voids a P3 respirator mask must be worn
9 - Function Room	Windows – sealant to glazing PUTTY		Minor damage - age	None	Previous Sample	5	7	12	Checked every August	Last Checked Aug 2024

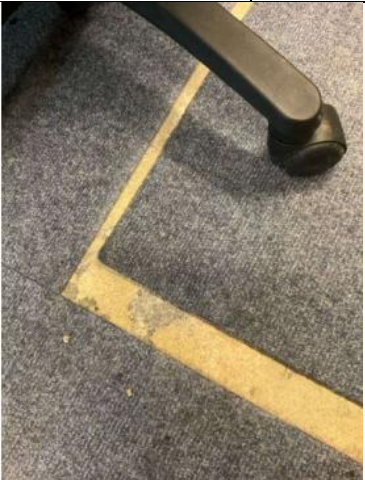
Plan No. and Location	Product / Asbestos Type	Extent	Condition	Surface Treatment	Sampled / Presumed	Material Score <i>fiber release</i>	Priority Score <i>disturbance</i>	Risk Total	Action & Due Date	Action Comment	Other Comments
10 - Duty Managers Office HDC 004	Under carpet/lino adhesive residues BITUMEN	12m ²	Minor damage – 1 tile lifted	Sealed	Strongly Presumed	5	6	11	Checked every August	Last Checked March 2025	-

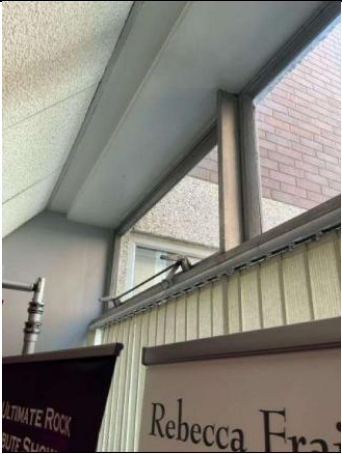
<p>DM OFFICE CARPET</p>											
11 - (what was) Café area HDC 003	Windows – sealant to glazing PUTTY	-	Minor damage - age	None	Strongly Presumed	5	6	11	Checked every August	Last Checked Aug 2024	-

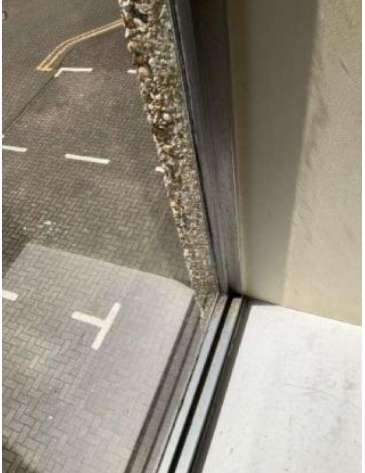
12 - Dance Studio HDC 046	Windows – sealant to glazing PUTTY	-	Minor damage - age	None	Strongly Presumed	5	7	12	Checked every August	Last Checked Aug 2024	-

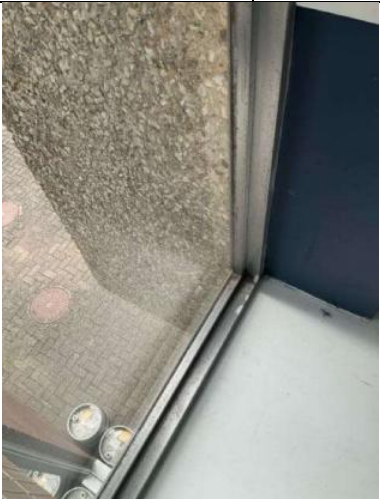
Plan No. and Location	Product / Asbestos Type	Extent	Condition	Surface Treatment	Sampled / Presumed	Material Score <i>fiber release</i>	Priority Score <i>disturbance</i>	Risk Total	Action & Due Date	Action Comment	Other Comments
13 - First floor landing HDC 047	Windows – sealant to glazing PUTTY	-	Minor damage – age	None	Strongly Presumed	5	5	10	Checked every August	Last Checked Aug 2024	-

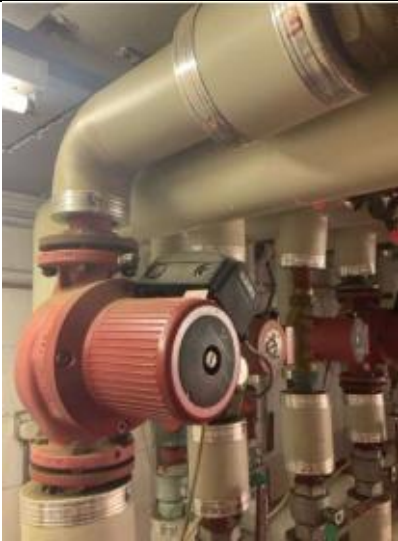
<p>1ST FLOOR WINDOWS</p>											
14 - Basement boiler room HDC 063	Pipework – GASKETS compressed to pipework flanges	-	Minor damage - age	None	Strongly Presumed	5	4	9	Checked every August	Last Checked Aug 2024	-

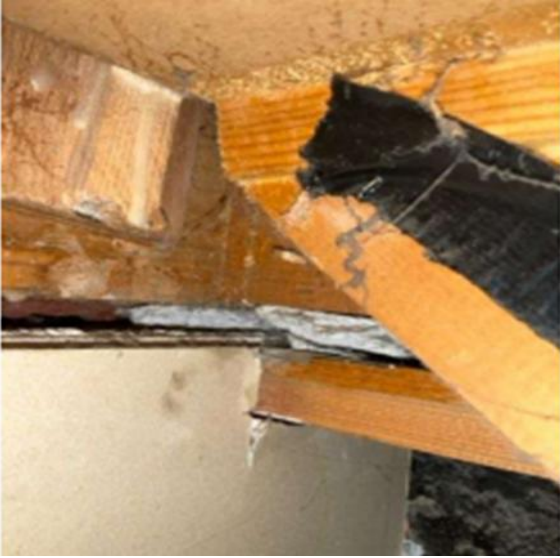
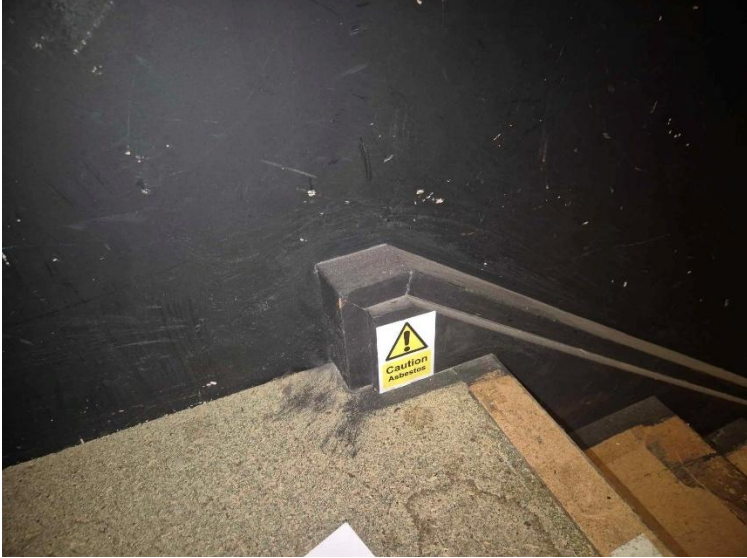
<p style="text-align: center;">BOILER ROOM</p>											
15 - Stairs off stage into basement HDC 071	Under stairs packing pieces in corner – adjacent top step. INSULATING BOARD	-	Medium	None	Sampled	8	1	9	Checked every August	Last Checked Aug 2024	-
15 – stairs off stage into basement HDC 072	Inside boxing packing pieces- adjacent top step. INSULATING BOARD	-	Medium	Painted	Sampled	8	1	9	Checked every August	Last Checked March 2025	-

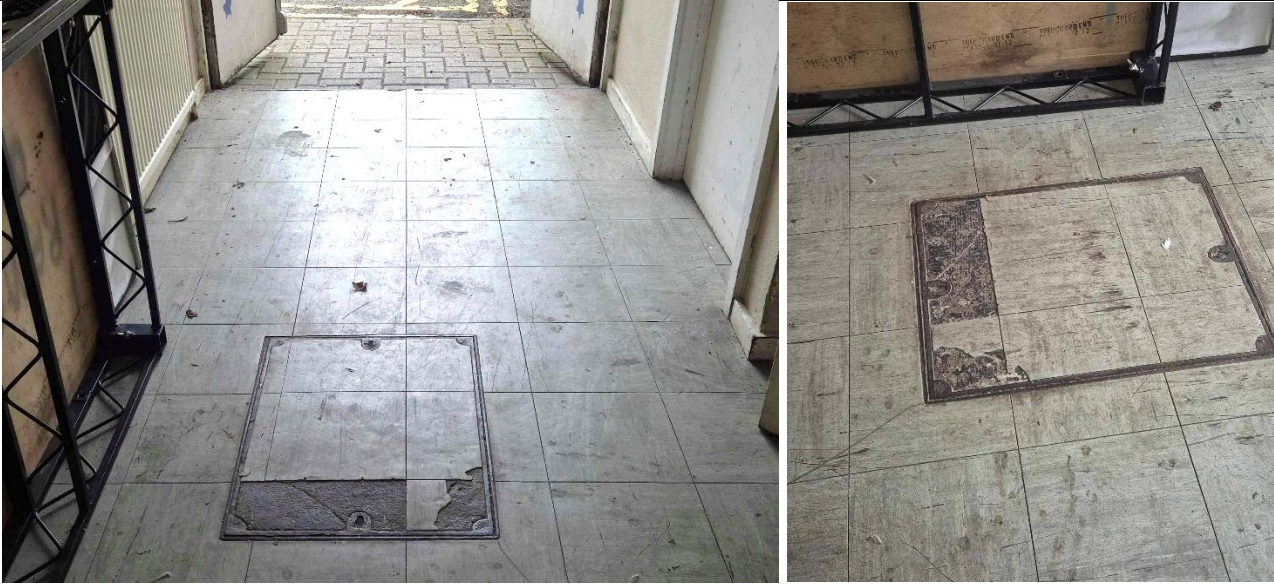
← UNDER STAIRS		← TOP STEP					
16 - Fire exit off auditorium to RVS HDC 079	Under carpet/lino residues beneath non asbestos floor tiles BITUMEN	20m ²	Minor damage – few tiles missing	Sealed	Previous sample	3	3	6	Encapsulate damage by 30/06/25 & monitor	Last Checked March 2025	-

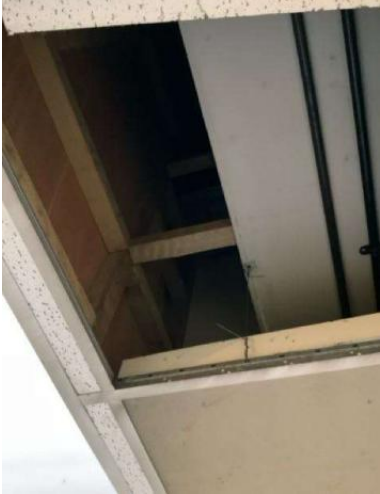
RVS LOFT HATCH

HALL TO RVS CORRIDOR FLOOR											
17 - RVS Loft HDC 314	Floor - Former roof covering felt BITUMEN	90m ²	Medium – felt exposed	None	Presumed	4	4	8	Checked every August	Last Checked Aug 2024	To enter voids a P3 respirator mask must be worn

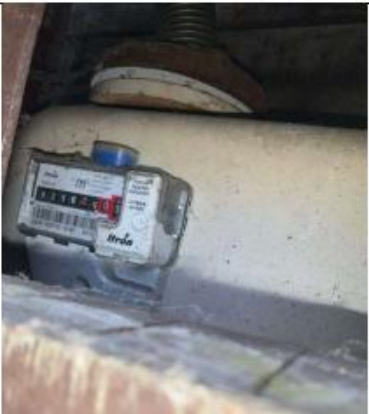
OUTSIDE GAS METRE

EXTERNAL – located by boiler room exit / the 3 parking spaces	GASKET (compressed) – gas meter flange	-	Good	None	Strongly Presumed	5	2	7	Checked every August	Last Checked Aug 2024	-
---	--	---	------	------	-------------------	---	---	---	----------------------	-----------------------	---

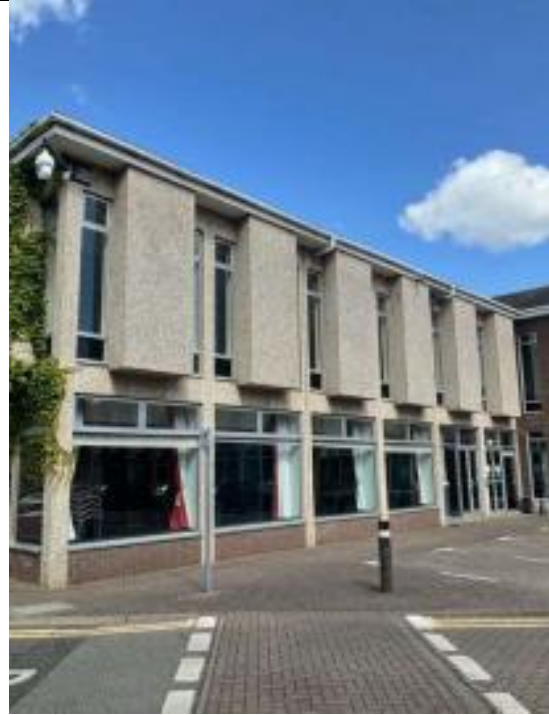
EXTERNAL WINDOWS

Plan No. and Location	Product / Asbestos Type	Extent	Condition	Surface Treatment	Sampled / Presumed	Material Score <i>fiber release</i>	Priority Score <i>disturbance</i>	Risk Total	Action & Due Date	Action Comment	Other Comments
EXTERNAL	Windows – sealant to glazing PUTTY	1m ²	Good	None	Strongly Presumed	5	2	7	Checked every August	Last Checked Aug 2024	-
