The Harlington Asbestos Register and Site Plans

Register covers locations with identified or strongly presumed asbestos containing materials

*Last reviewed August 2025
Due for review August 2026*

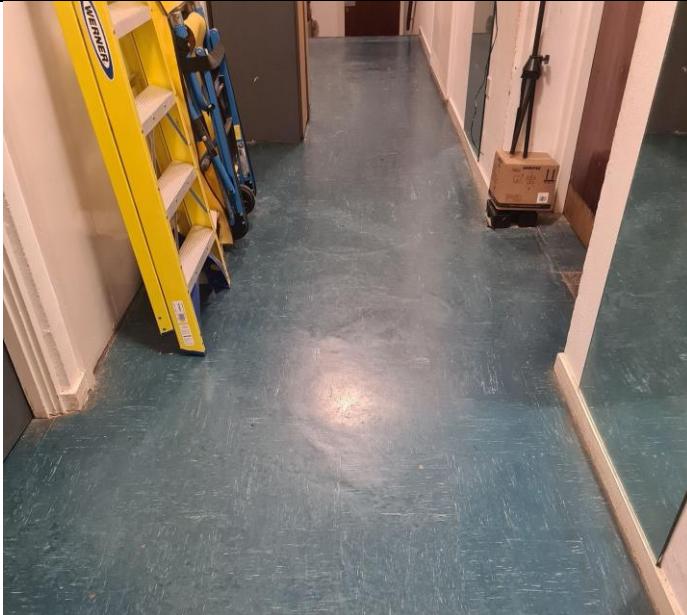
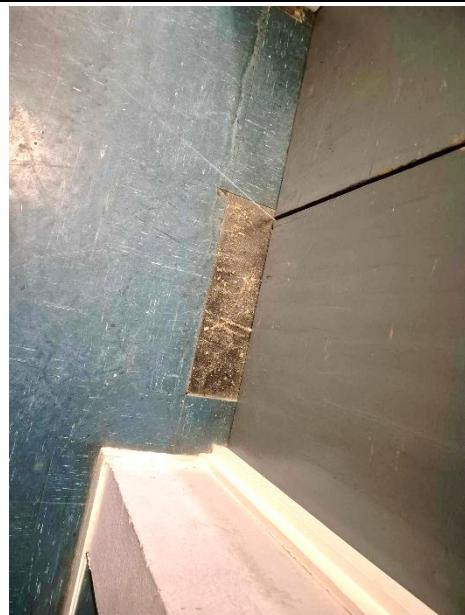
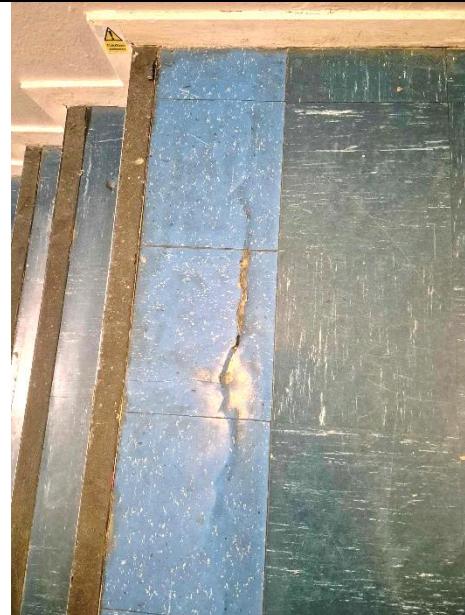
BACKSTAGE FLOOR

| Plan No. and Location | Product / Asbestos Type | Extent | Condition | Surface Treatment | Sampled / Presumed | Material Score <i>fiber release</i> | Priority Score <i>disturbance</i> | Risk Total | Action & Due Date | Action Comment | Other Comments |
|--|--|---|---|---|---|--|---|---|---|---|---|
| 1 - Backstage corridor, both backstage changing rooms and stairs to basement HDC 033 | BITUMEN floor tile adhesive & blue VINYL floor tiles | 32m ² | Minor damage - cracked top step and one missing tile under stage door | Sealed | Previous Sample | 3 | 4 | 7 | Monitor – material release very unlikely. No works carried out on these areas. Cover as temporary measure if required (tape). | Last Checked Aug 2025 | - |

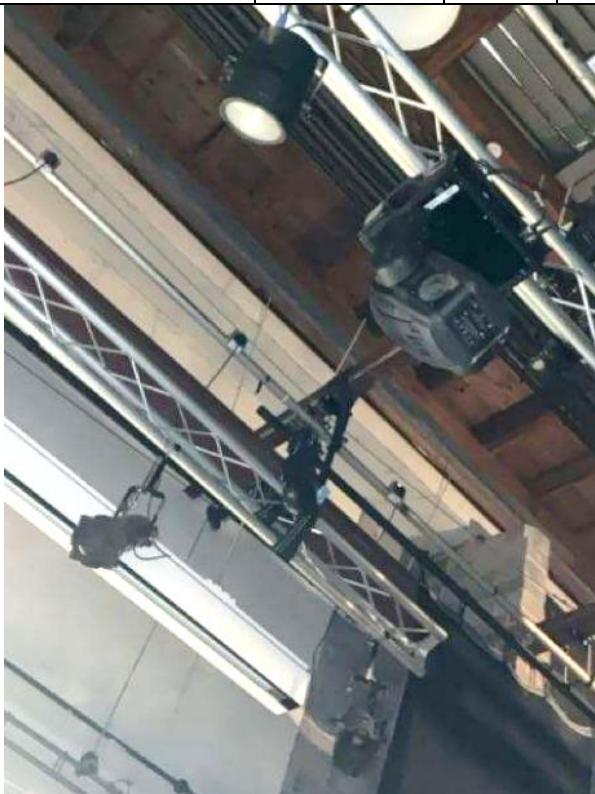
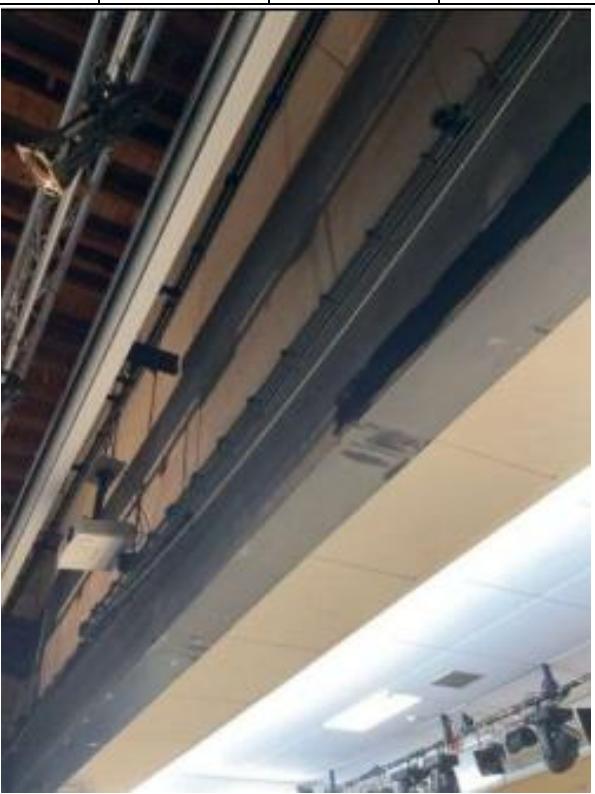
| Plan No. and Location | Product / Asbestos Type | Extent | Condition | Surface Treatment | Sampled / Presumed | Material Score <i>fiber release</i> | Priority Score <i>disturbance</i> | Risk Total | Action & Due Date | Action Comment | Other Comments |
|---|--|---|---|---|---|--|---|---|---|---|---|
| BEAM CASING | | | | | | VERTICAL PANELS | | | | | |

| 2 - Stage: High level white boxed casing – top of wall HDC 012 | High level casing INSULATING BOARD | 16m ² | Good | Painted | Strongly Presumed | 9 | 4 | 13 | Checked every August | Last Checked Aug 2025 | - |

| Plan No. and Location | Product / Asbestos Type | Extent | Condition | Surface Treatment | Sampled / Presumed | Material Score <i>fiber release</i> | Priority Score <i>disturbance</i> | Risk Total | Action & Due Date | Action Comment | Other Comments |
|---|--|---|---|---|---|--|---|---|---|---|---|
| 2 - Stage: Vertical panels to beam to stage opening HDC 012 | Vertical panels to beam INSULATING BOARD | 12m ² | Minor damage - area of paint chipped away | Painted | Previous Sample | 8 | 5 | 13 | Damage now encapsulated | Last Checked Aug 2025 | - |

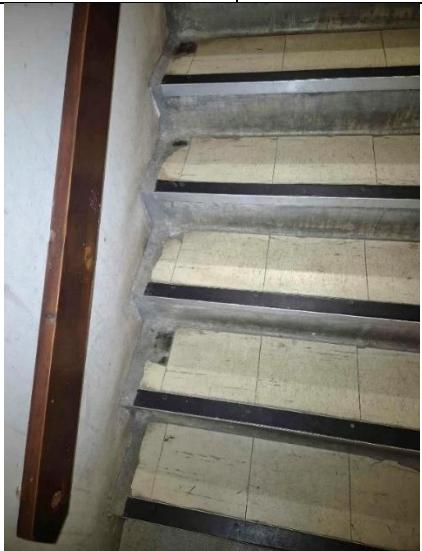
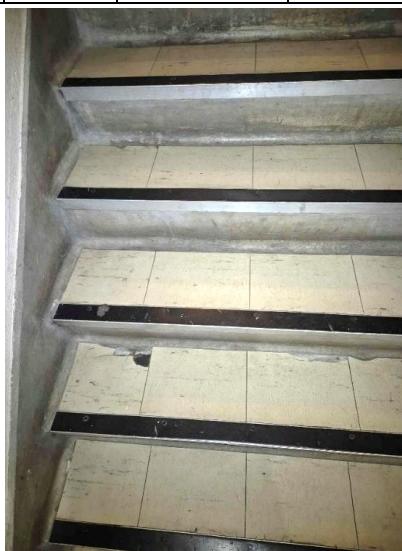
KITCHEN STAIRS – bottom (right) top (left)

| Plan No. and Location | Product / Asbestos Type | Extent | Condition | Surface Treatment | Sampled / Presumed | Material Score fiber release | Priority Score disturbance | Risk Total | Action & Due Date | Action Comment | Other Comments |
|---|---|---|---|---|---|---|---|---|---|---|---|
| 3 - Main Kitchen stairs leading to 2 nd Floor HDC 020 | BITUMEN floor tile adhesive & white VINYL floor tiles | 10m ² | Minor damage – some sections of tiles missing | Sealed | Previous Sample | 2 | 4 | 6 | Monitor – material release very unlikely. No works carried out on these areas. Cover as temporary measure if required (tape). | Last Checked Aug 2025 | - |

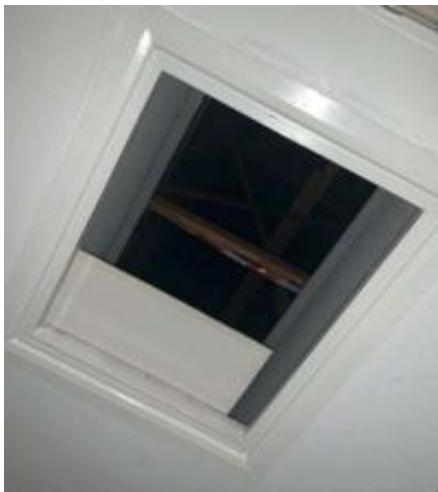
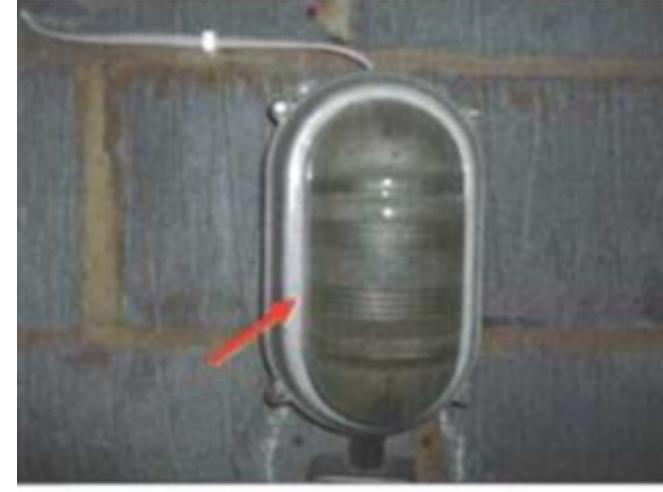
| Plan No. and Location | Product / Asbestos Type | Extent | Condition | Surface Treatment | Sampled / Presumed | Material Score <i>fiber release</i> | Priority Score <i>disturbance</i> | Risk Total | Action & Due Date | Action Comment | Other Comments |
|---|---|---|---|---|---|--|---|---|---|---|---|
| GM OFFICE LOFT HATCH | | | | FITTING | | | | | | | |

| 4 – Loft: sealant around light fitting. The loft area accessed via the hatch above the General Managers Office | Light fitting sealant | - | Good | None | Previous Sample | 4 | 4 | 8 | Checked every August | Last Checked Aug 2025 | - |

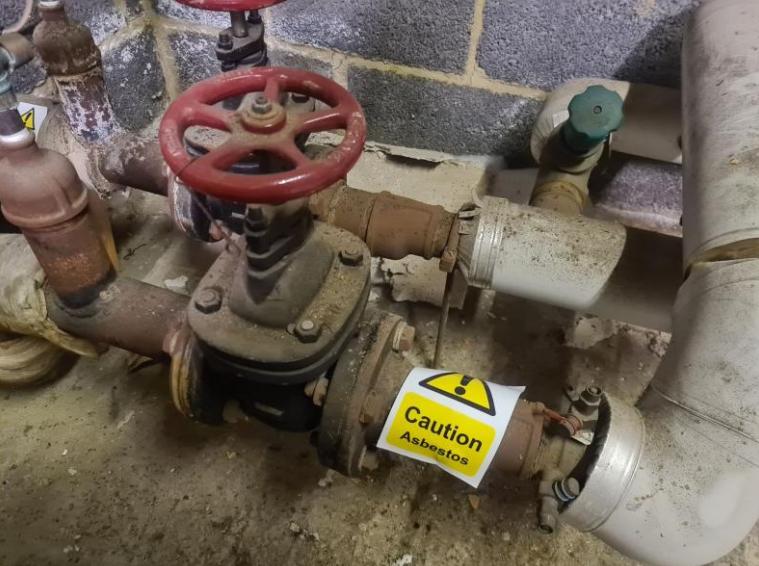
| Plan No. and Location | Product / Asbestos Type | Extent | Condition | Surface Treatment | Sampled / Presumed | Material Score <i>fiber release</i> | Priority Score <i>disturbance</i> | Risk Total | Action & Due Date | Action Comment | Other Comments |
|---|---|---|---|---|---|--|---|---|---|---|---|
| 5 - Plant Room i.e. the main loft area, on right hand side of space once you reach top of access ladder. Accessed via ladder in storeroom behind dance studio. HDC 075 | GASKETS compressed on pipe flanges | - | Good | None | Previous Sample | 2 | 2 | 4 | Checked every August | Last Checked Aug 2025 | - |

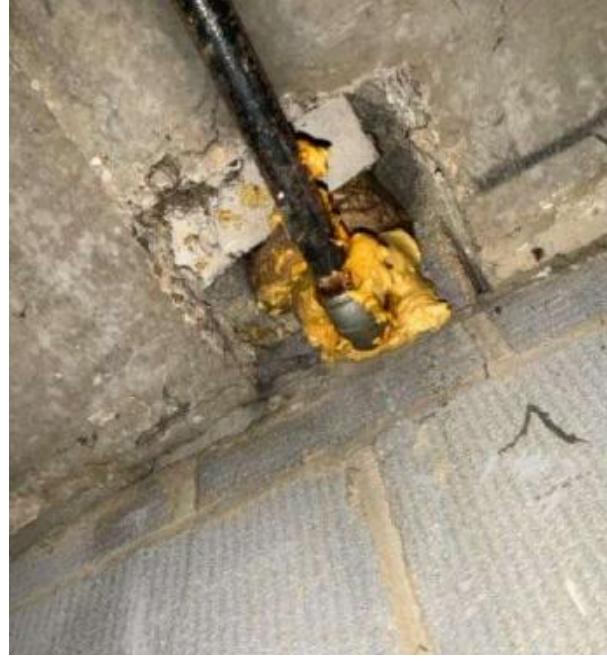
| Plan No. and Location | Product / Asbestos Type | Extent | Condition | Surface Treatment | Sampled / Presumed | Material Score <i>fiber release</i> | Priority Score <i>disturbance</i> | Risk Total | Action & Due Date | Action Comment | Other Comments |
|---|---|---|---|---|---|--|---|---|---|---|--|
| 7 - Outside store i.e. 'market traders' - as you walk into store, about halfway across back wall where wall meets ceiling HDC 064 | Pipe Duct - Panel within pipe exit to ceiling - rear of area INSULATING BOARD | - | Minor damage – wear to panel | None | Previous Sample | 8 | 3 | 11 | Damage now encapsulated | Last Checked Aug 2025 | Add new photo when can view area around market equip |

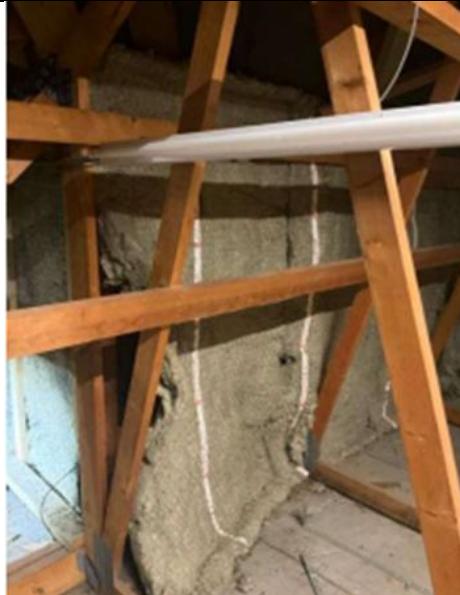
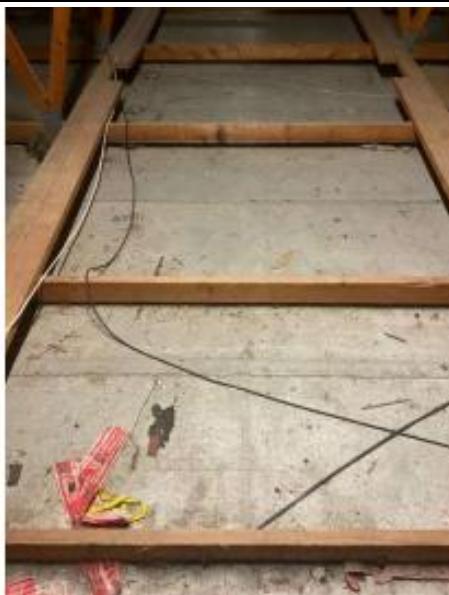
| Plan No. and Location | Product / Asbestos Type | Extent | Condition | Surface Treatment | Sampled / Presumed | Material Score <i>fiber release</i> | Priority Score <i>disturbance</i> | Risk Total | Action & Due Date | Action Comment | Other Comments |
|--|---|---|---|---|---|--|---|---|---|---|--|
| 8 - Roof void via right hand door in main loft accessed via ladder in store room behind dance studio. HDC 076 | Roof felt – former roof including debris around penetration BITUMEN | 150m ² | High risk – felt exposed and debris | None | Previous Sample | 5 | 3 | 8 | Checked every August | Last Checked Aug 2025 | To enter voids a P3 respirator mask must be worn |

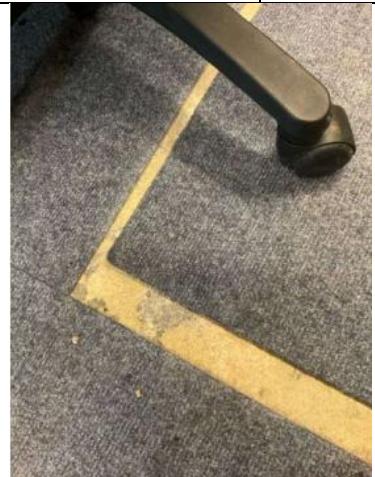
| Plan No. and Location | Product / Asbestos Type | Extent | Condition | Surface Treatment | Sampled / Presumed | Material Score <i>fiber release</i> | Priority Score <i>disturbance</i> | Risk Total | Action & Due Date | Action Comment | Other Comments |
|---|---|---|---|---|---|--|---|---|---|---|---|
| | DM OFFICE CARPET | | | | | | | | | | |

| Plan No. and Location | Product / Asbestos Type | Extent | Condition | Surface Treatment | Sampled / Presumed | Material Score <i>fiber release</i> | Priority Score <i>disturbance</i> | Risk Total | Action & Due Date | Action Comment | Other Comments |
|---|---|---|---|---|---|--|---|---|---|---|---|
| 10 - Duty Managers Office HDC 004 | Under carpet/lino adhesive residues BITUMEN | 12m ² | Minor damage – 1 tile lifted | Sealed | Strongly Presumed | 5 | 6 | 11 | Checked every August | Last Checked Aug 2025 | - |

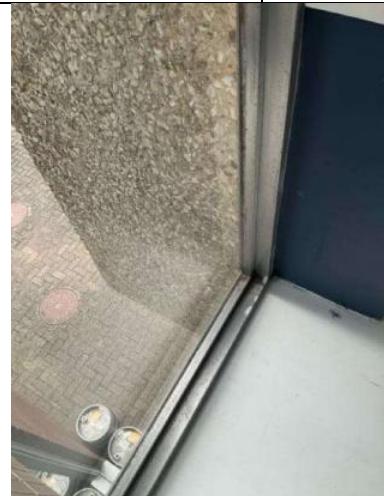
1ST FLOOR WINDOWS

| Plan No. and Location | Product / Asbestos Type | Extent | Condition | Surface Treatment | Sampled / Presumed | Material Score <i>fiber release</i> | Priority Score <i>disturbance</i> | Risk Total | Action & Due Date | Action Comment | Other Comments |
|--|--|---|---|---|---|--|---|---|---|---|---|
| 13 - First floor landing HDC 047 | Windows – sealant to glazing PUTTY | - | Minor damage – age | None | Strongly Presumed | 5 | 5 | 10 | Checked every August | Last Checked Aug 2025 | - |

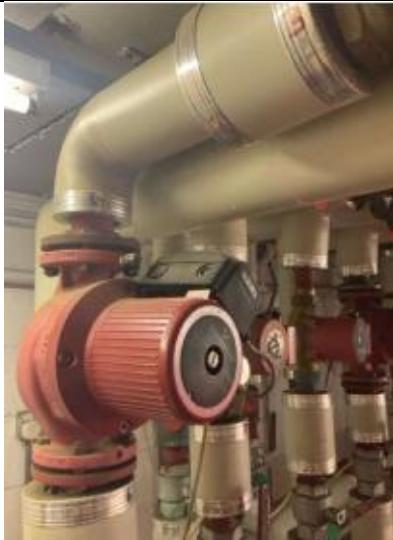
| Plan No. and Location | Product / Asbestos Type | Extent | Condition | Surface Treatment | Sampled / Presumed | Material Score <i>fiber release</i> | Priority Score <i>disturbance</i> | Risk Total | Action & Due Date | Action Comment | Other Comments |
|---|---|---|---|---|---|--|---|---|---|---|---|
| | | | BOILER ROOM | | | | | | | | |

| 14 - Basement boiler room HDC 063 | Pipework – GASKETS compressed to pipework flanges | - | Minor damage - age | None | Strongly Presumed | 5 | 4 | 9 | Checked every August | Last Checked Aug 2025 | - |

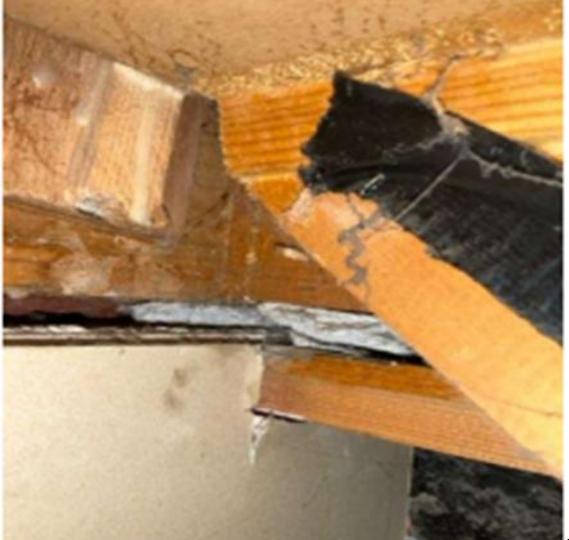
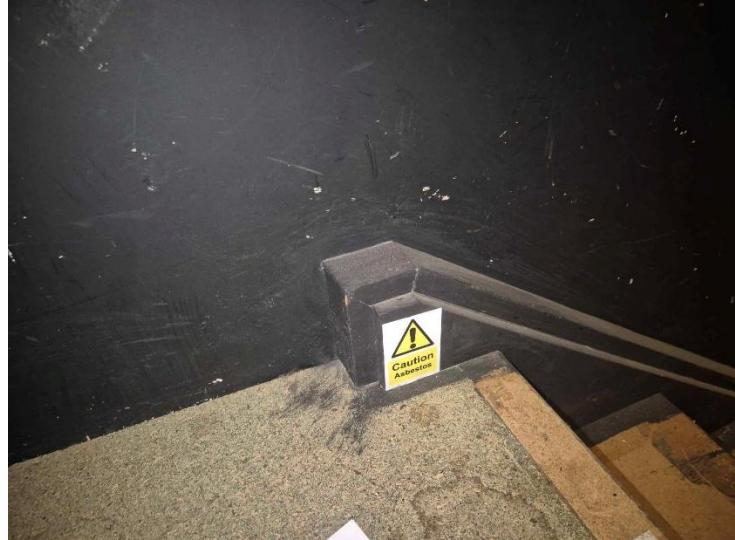
| Plan No. and Location | Product / Asbestos Type | Extent | Condition | Surface Treatment | Sampled / Presumed | Material Score <i>fiber release</i> | Priority Score <i>disturbance</i> | Risk Total | Action & Due Date | Action Comment | Other Comments |
|---|--|---|---|---|---|--|---|---|---|---|---|
| | | <UNDER STAIRS | < TOP STEP | | | | | | | | |

| Plan No. and Location | Product / Asbestos Type | Extent | Condition | Surface Treatment | Sampled / Presumed | Material Score <i>fiber release</i> | Priority Score <i>disturbance</i> | Risk Total | Action & Due Date | Action Comment | Other Comments |
|---|---|---|---|---|---|--|---|---|---|---|---|
| 15 - Stairs off stage into basement HDC 071 | Under stairs packing pieces in corner – adjacent top step. INSULATING BOARD | - | Medium | None | Sampled | 8 | 1 | 9 | Checked every August | Last Checked Aug 2025 | - |
| 15 – stairs off stage into basement HDC 072 | Inside boxing packing pieces- adjacent top step. INSULATING BOARD | - | Medium | Painted | Sampled | 8 | 1 | 9 | Checked every August | Last Checked Aug 2025 | - |

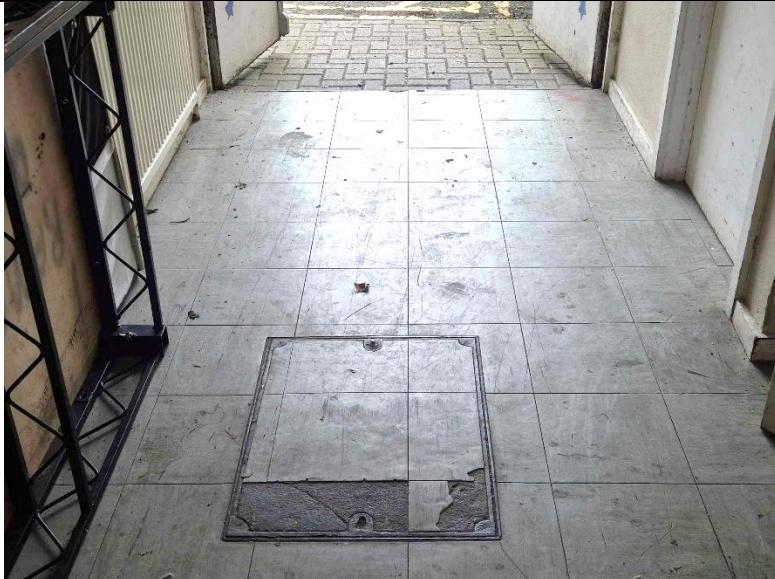
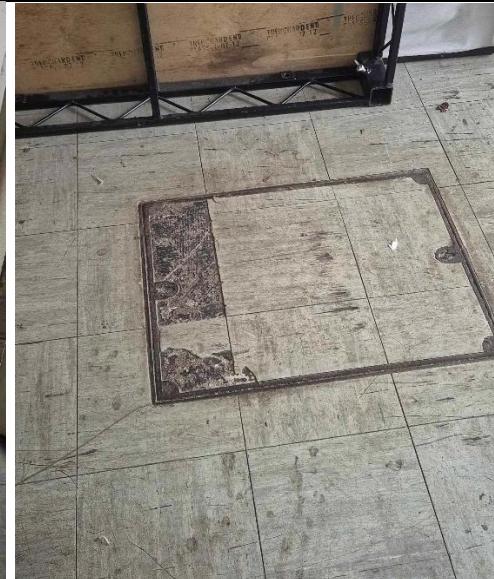
| Plan No. and Location | Product / Asbestos Type | Extent | Condition | Surface Treatment | Sampled / Presumed | Material Score <i>fiber release</i> | Priority Score <i>disturbance</i> | Risk Total | Action & Due Date | Action Comment | Other Comments |
|---|--|---|---|---|---|--|---|---|---|---|--|
| | | HALL TO RVS CORRIDOR FLOOR | | | | | | | | | |

| Plan No. and Location | Product / Asbestos Type | Extent | Condition | Surface Treatment | Sampled / Presumed | Material Score <i>fiber release</i> | Priority Score <i>disturbance</i> | Risk Total | Action & Due Date | Action Comment | Other Comments |
|---|--|---|---|---|---|--|---|---|---|---|---|
| 16 - Fire exit off auditorium to RVS HDC 079 | Under carpet/lino residues beneath non asbestos floor tiles BITUMEN | 20m ² | Minor damage – few tiles missing | Sealed | Previous sample | 3 | 3 | 6 | Monitor – material release very unlikely. No works carried out on these areas. Cover as temporary measure if required (tape). | Last Checked Aug 2025 | - |
