The Harlington Asbestos Register and Site Plans

Register covers locations with identified or strongly presumed asbestos containing materials

Last reviewed August 2025, amended Jan 2026

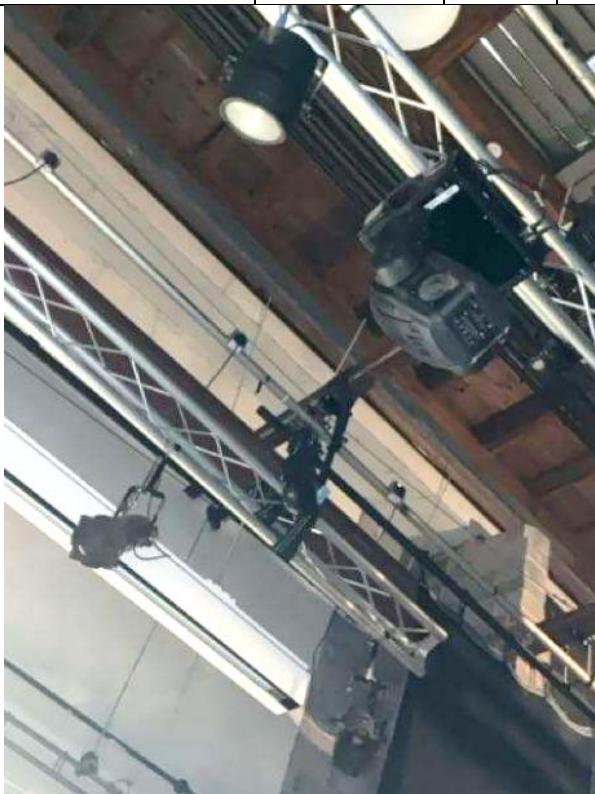
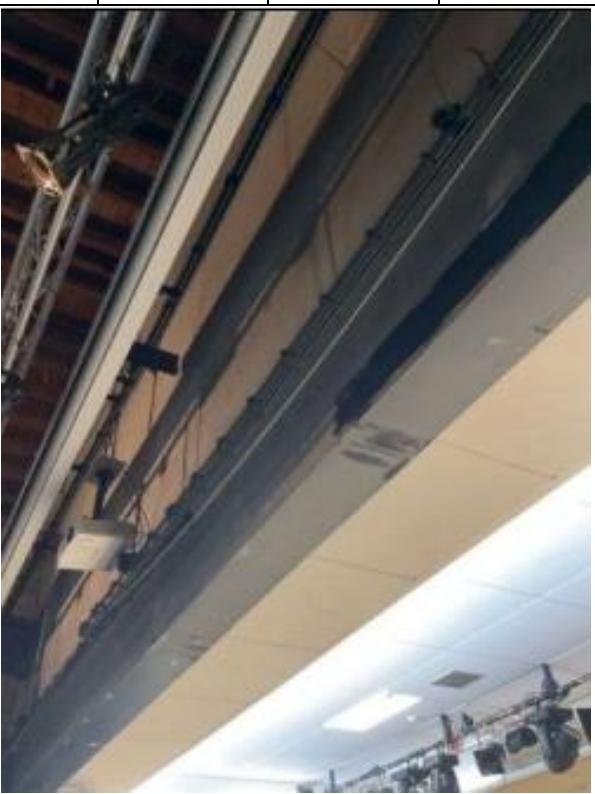
BEAM CASING						VERTICAL PANELS

Plan No. and Location	Product / Asbestos Type	Extent	Condition	Surface Treatment	Sampled / Presumed	Material Score <i>fiber release</i>	Priority Score <i>disturbance</i>	Risk Total	Action & Due Date	Action Comment	Other Comments
2 - Stage: Vertical panels to beam to stage opening HDC 012	Vertical panels to beam INSULATING BOARD	12m ²	Minor damage - area of paint chipped away	Painted	Previous Sample	8	5	13	Damage now encapsulated	Last Checked Aug 2025	-

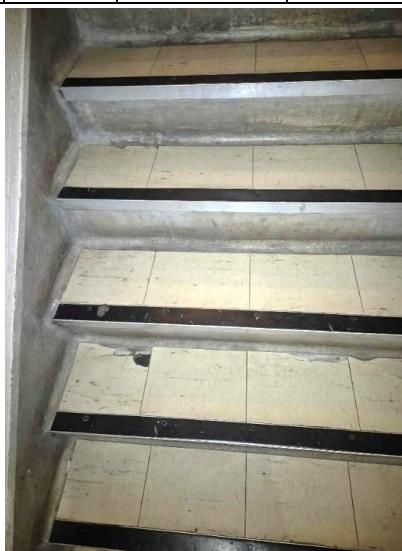
KITCHEN STAIRS – bottom (right) top (left)

Plan No. and Location	Product / Asbestos Type	Extent	Condition	Surface Treatment	Sampled / Presumed	Material Score <i>fiber release</i>	Priority Score <i>disturbance</i>	Risk Total	Action & Due Date	Action Comment	Other Comments
3 - Main Kitchen stairs leading to 2 nd Floor HDC 020	BITUMEN floor tile adhesive & white VINYL floor tiles	10m ²	Minor damage – some sections of tiles missing	Sealed	Previous Sample	2	4	6	Monitor – material release very unlikely. No works carried out on these areas. Cover as temporary measure if required (tape).	Last Checked Aug 2025	-

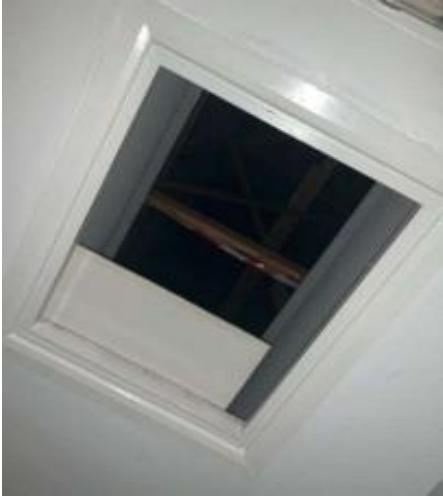
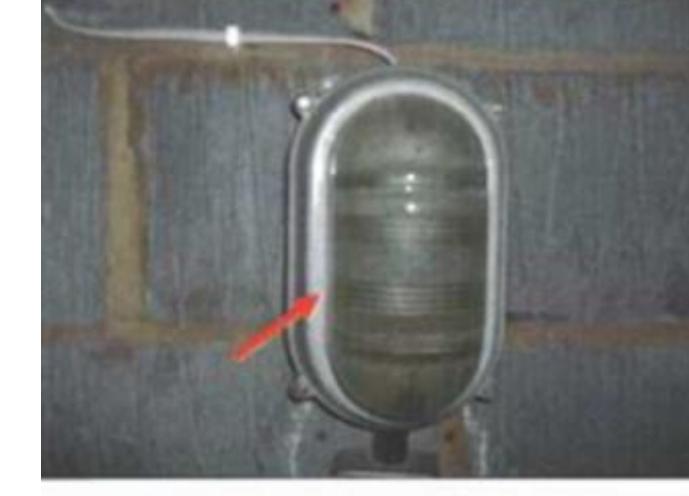
GM OFFICE LOFT HATCH

4 – Loft: sealant around light fitting. The loft area accessed via the hatch above the General Managers Office	Light fitting sealant	-	Good	None	Previous Sample	4	4	8	Checked every August	Last Checked Aug 2025	-
--	-----------------------	---	------	------	-----------------	---	---	---	----------------------	-----------------------	---

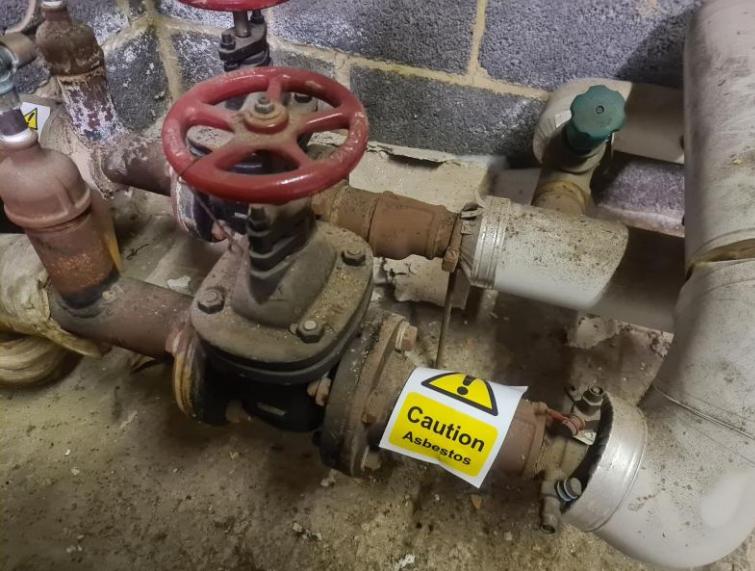
FITTING	<p>5 - Plant Room i.e. the main loft area, on right hand side of space once you reach top of access ladder. Accessed via ladder in storeroom behind dance studio. HDC 075</p>	GASKETS compressed on pipe flanges	-	Good	None	Previous Sample	2	2	4	Checked every August	Last Checked Aug 2025	-

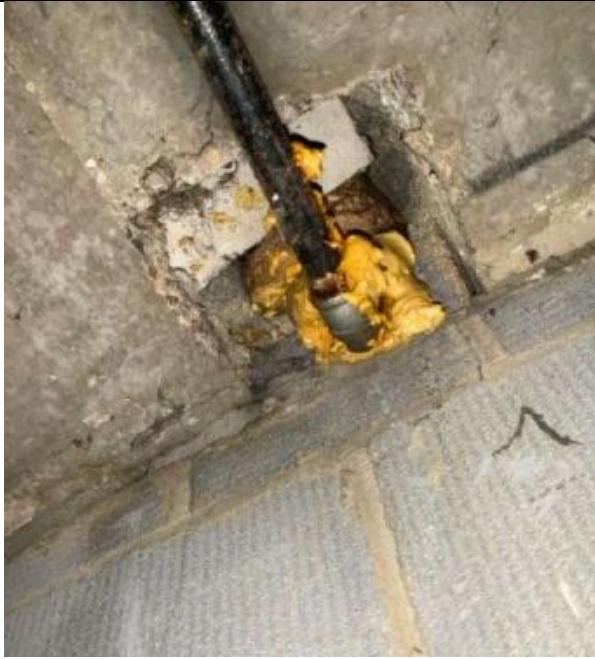
8 - Roof void via right hand door in main loft accessed via ladder in store room behind dance studio. HDC 076	Roof felt – former roof including debris around penetration BITUMEN	150m ²	High risk – felt exposed and debris	None	Previous Sample	5	3	8	Checked every August	Last Checked Aug 2025	To enter voids a P3 respirator mask must be worn

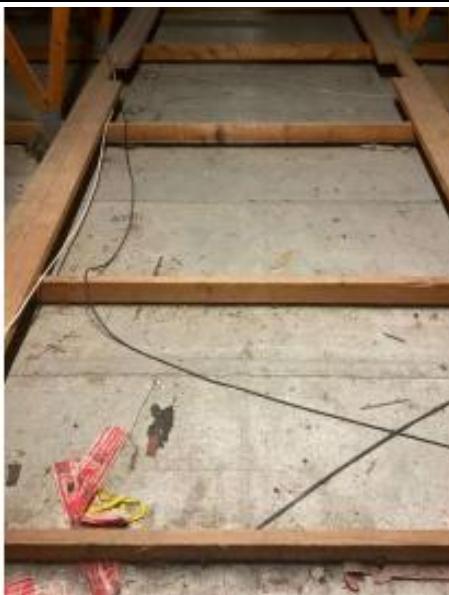
8 - Roof void via right hand door in main loft accessed via ladder in store room behind dance studio. HDC 076	Floor - silver floor covering former roof BITUMEN	150m ²	Minor damage - age	None		3	3	6	Checked every August	Last Checked Aug 2025	To enter voids a P3 respirator mask must be worn
8 - Roof void via right hand door in main loft accessed via ladder in store room behind dance studio. Second void accessed through first void. HDC 077	Roof felt – former roof including debris around penetration BITUMEN	220m ²	High risk – felt exposed and debris	None	Previous Sample	5	3	8	Checked every August	Last Checked Aug 2025	To enter voids a P3 respirator mask must be worn

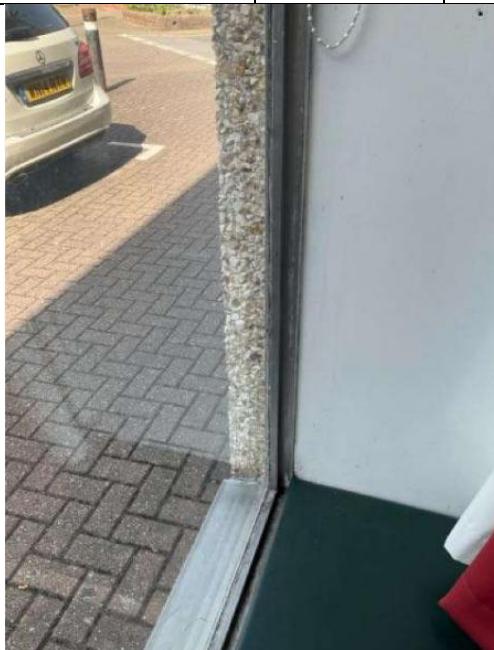
FUNCTION ROOM WINDOWS

Plan No. and Location	Product / Asbestos Type	Extent	Condition	Surface Treatment	Sampled / Presumed	Material Score <i>fiber release</i>	Priority Score <i>disturbance</i>	Risk Total	Action & Due Date	Action Comment	Other Comments
8 - Roof void via right hand door in main loft accessed via ladder in store room behind dance studio. Second void accessed through first void. HDC 077 & 078	Floor - silver floor covering former roof BITUMEN	235m ²	Minor damage - age	None	Previous Sample	3	3	6	Checked every August	Last Checked Aug 2025	To enter voids a P3 respirator mask must be worn
9 - Function Room	Windows – sealant to glazing PUTTY		Minor damage - age	None	Previous Sample	5	7	12	Checked every August	Last Checked Aug 2025

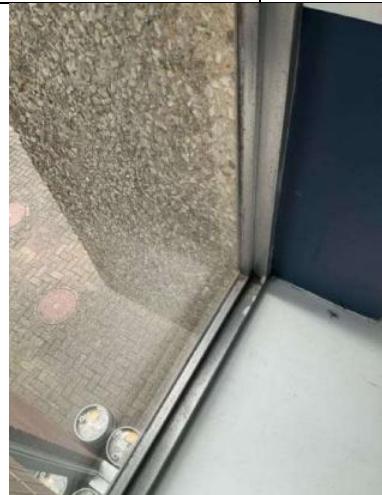
1ST FLOOR WINDOWS

Plan No. and Location	Product / Asbestos Type	Extent	Condition	Surface Treatment	Sampled / Presumed	Material Score <i>fiber release</i>	Priority Score <i>disturbance</i>	Risk Total	Action & Due Date	Action Comment	Other Comments
13 - First floor landing HDC 047	Windows – sealant to glazing PUTTY	-	Minor damage – age	None	Strongly Presumed	5	5	10	Checked every August	Last Checked Aug 2025	-

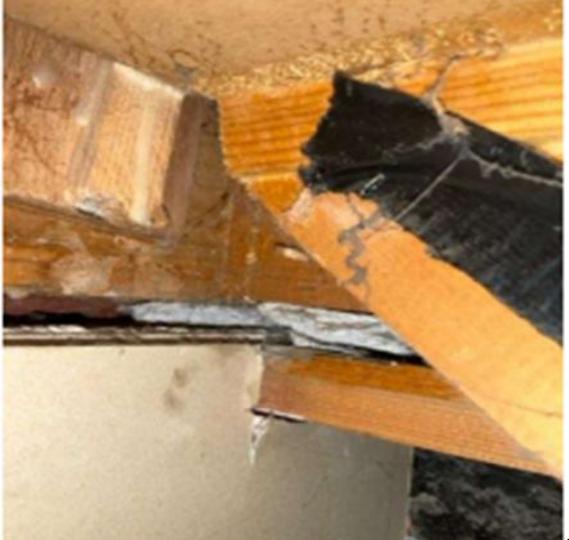
BOILER ROOM											
15 - Stairs off stage into basement HDC 071	Under stairs packing pieces in corner – adjacent top step. INSULATING BOARD	-	Medium	None	Sampled	8	1	9	Checked every August	Last Checked Aug 2025	-
15 – stairs off stage into basement HDC 072	Inside boxing packing pieces- adjacent top step. INSULATING BOARD	-	Medium	Painted	Sampled	8	1	9	Checked every August	Last Checked Aug 2025	-

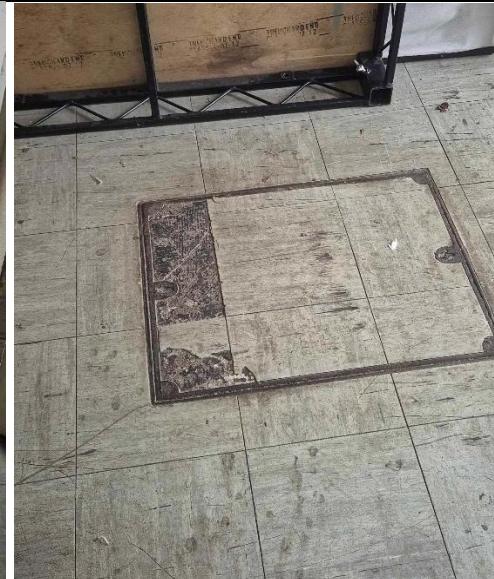
HALL TO RVS CORRIDOR FLOOR

<UNDER STAIRS	< TOP STEP	16 - Fire exit off auditorium to RVS HDC 079	Under carpet/lino residues beneath non asbestos floor tiles BITUMEN	20m ²	Minor damage – few tiles missing	Sealed	Previous sample	3	3	6	Monitor – material release very unlikely. No works carried out on these areas. Cover as temporary measure if required (tape).	Last Checked Aug 2025	-

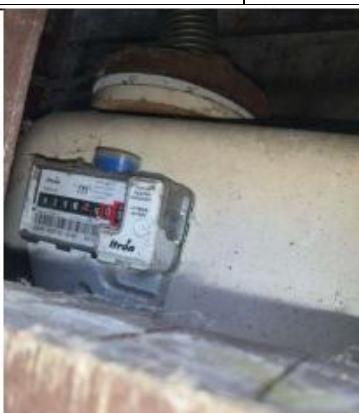
Plan No. and Location	Product / Asbestos Type	Extent	Condition	Surface Treatment	Sampled / Presumed	Material Score <i>fiber release</i>	Priority Score <i>disturbance</i>	Risk Total	Action & Due Date	Action Comment	Other Comments
EXTERNAL – located by boiler room exit / the 3 parking spaces	GASKET (compressed) – gas meter flange	-	Good	None	Strongly Presumed	5	2	7	Checked every August	Last Checked Aug 2025	-

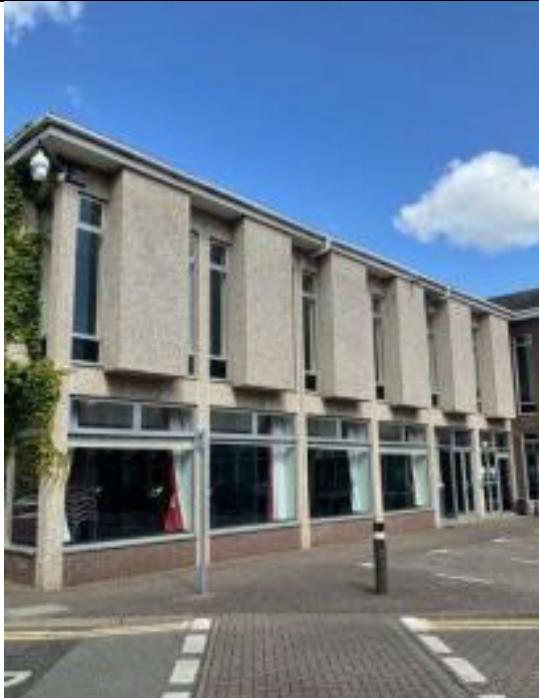
EXTERNAL WINDOWS

OUTSIDE GAS METRE									
EXTERNAL	Windows – sealant to glazing PUTTY	1m ²	Good	None	Strongly Presumed	5	2	7	Checked every August	Last Checked Aug 2025	-
