Cooper & Withycombe

**The Harlington
236 Fleet Road
Fleet
Hampshire
GU51 4BY**

Condition Survey Report

January 2020

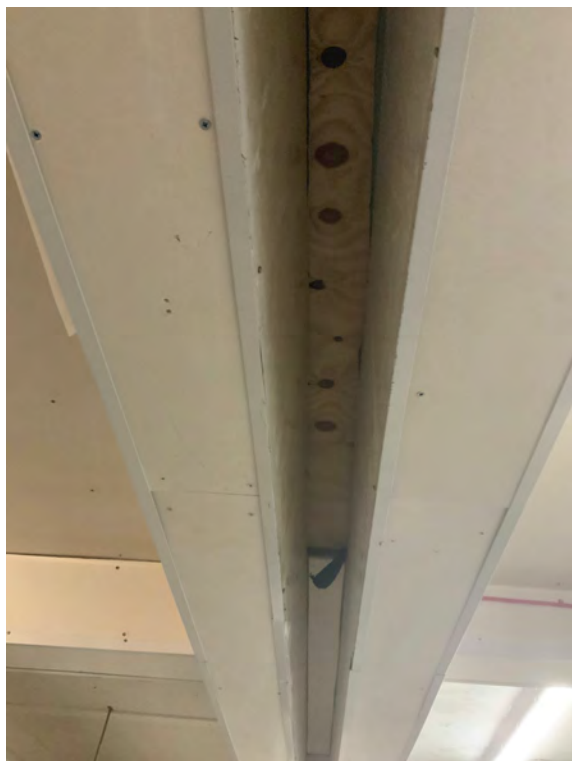
P59 Boiler Room - Ceiling
