The Harlington Asbestos Register and Site Plans

**Register covers locations with identified or strongly presumed
asbestos containing materials**

Last reviewed March 2025

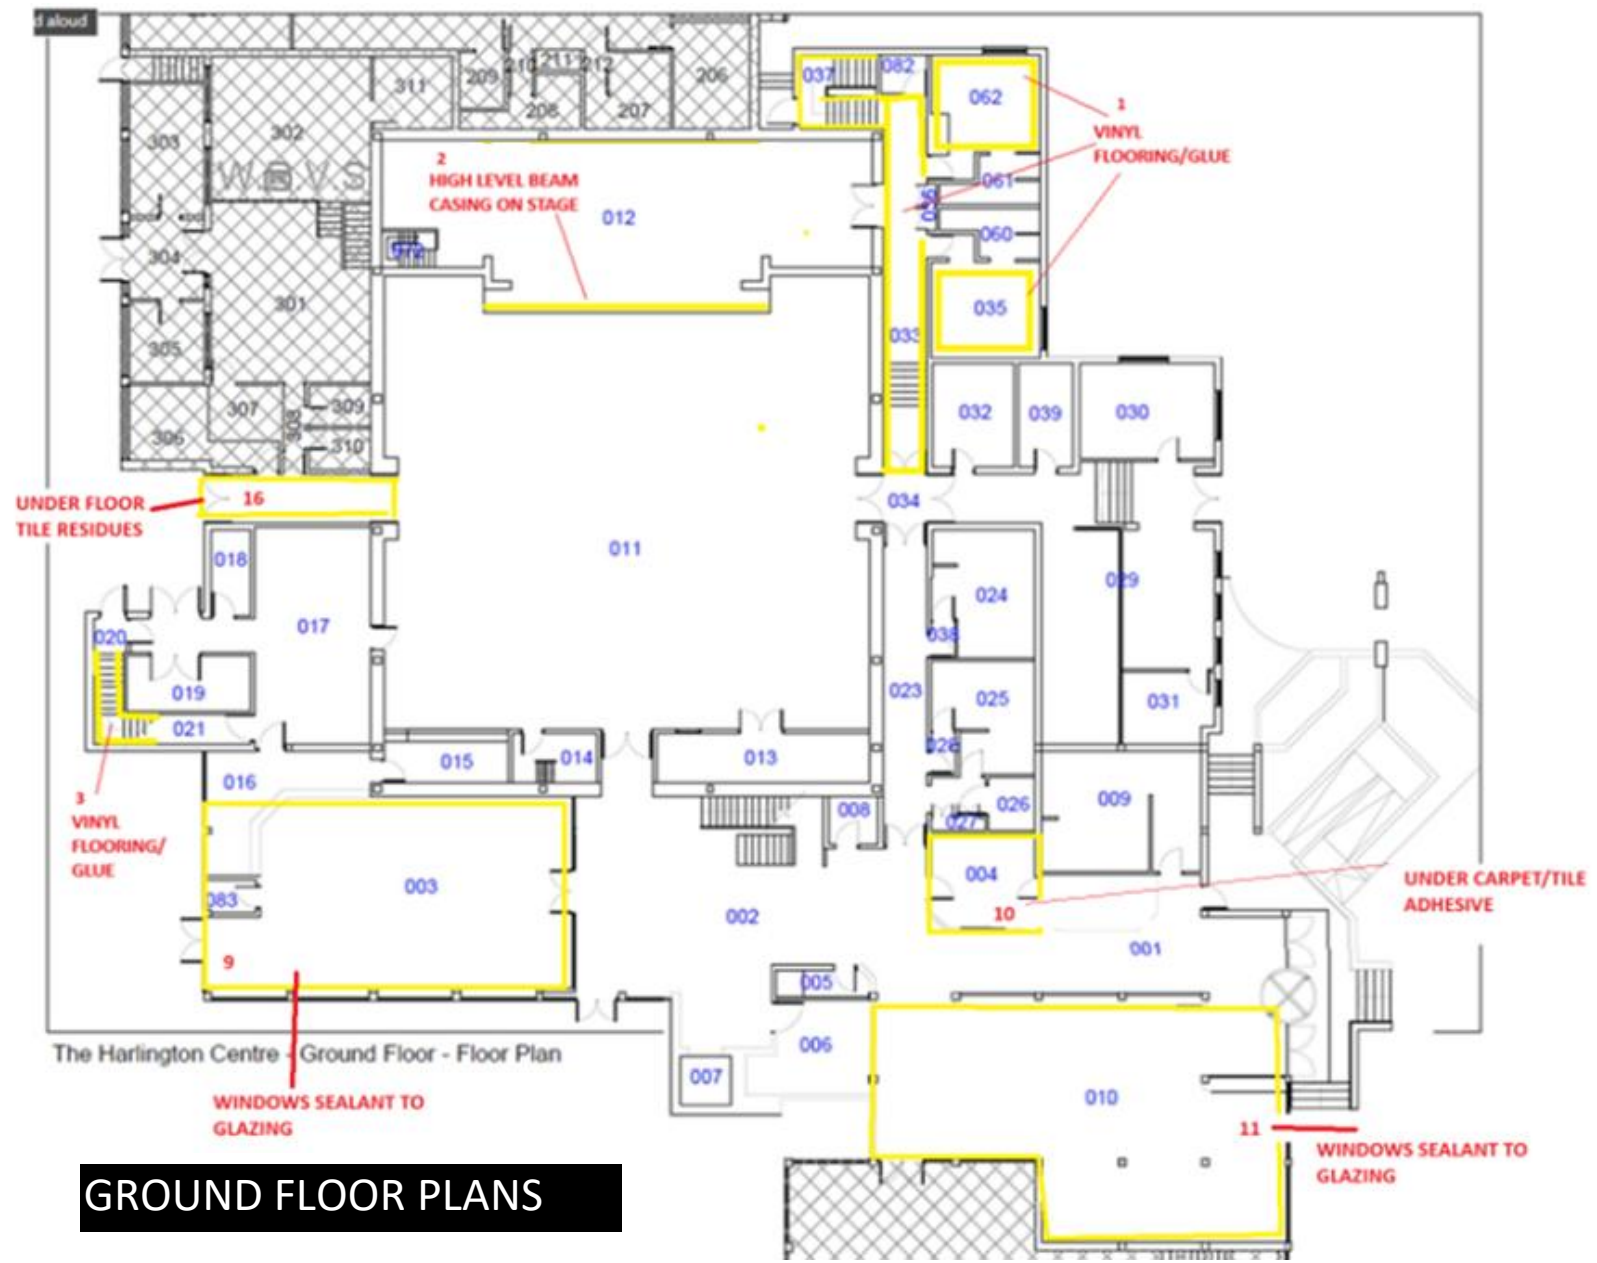
GROUND FLOOR PLANS

17 – RVS LOFT FLOOR
- FORMER ROOF
COVERING

3
VINYL
FLOORING/GLUE

4
LIGHT FITTING
SEALANT
(VOID ABOVE GM OFFICE)

12
13
WINDOWS SEALANT TO
GLAZING
