Cooper & Withycombe

**The Harlington
236 Fleet Road
Fleet
Hampshire
GU51 4BY**

Condition Survey Report

January 2020

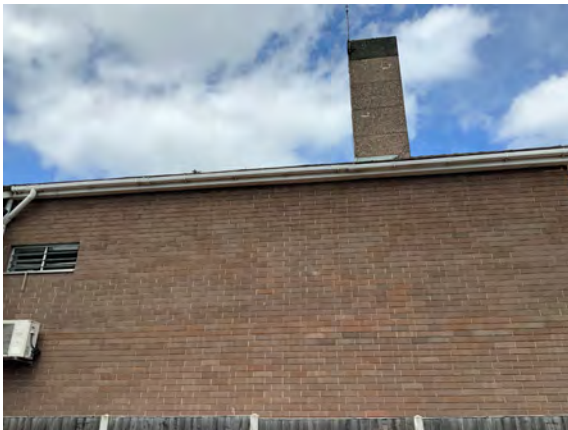
P7 Guttering above changing rooms. Some gutter joints disturbed.

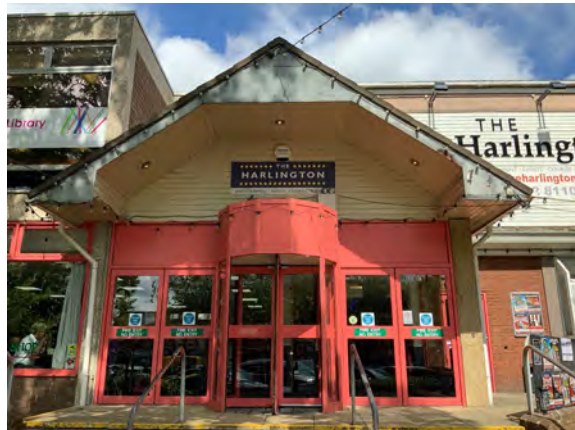
P24 Front fascia board to entrance starting to decay.

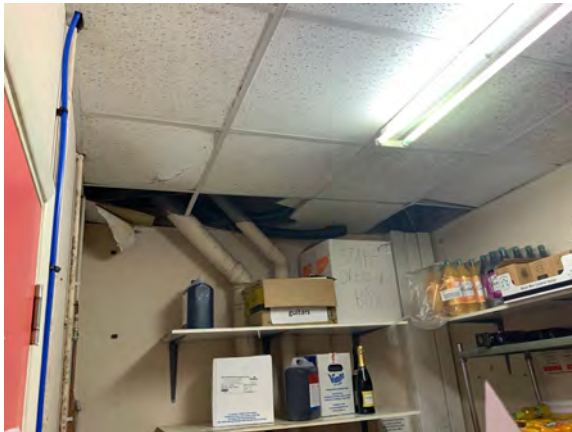
P39 Bar Store – Damage to ceiling tiles including water staining

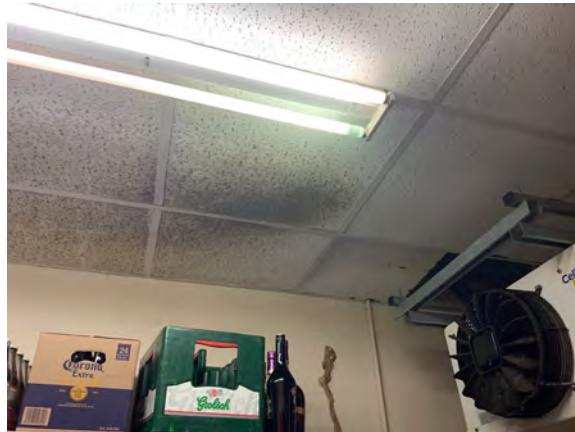
P40 Bar Store – Staining and missing tile next to air conditioning unit.

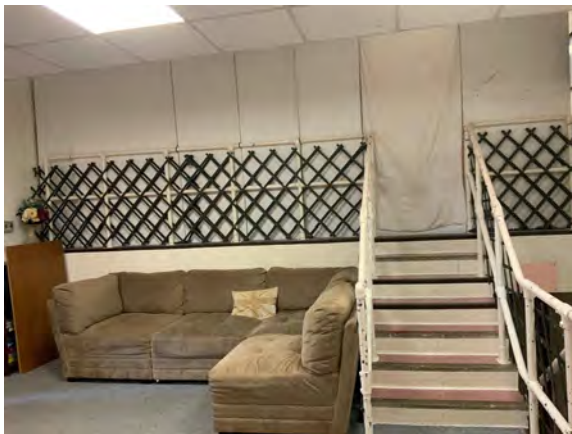
P63 Stage

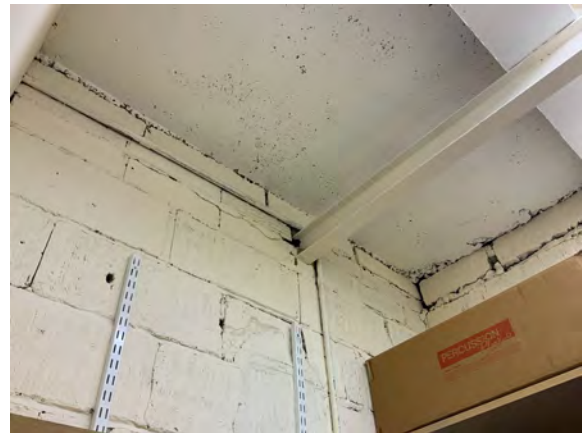
P90 First Floor, Store Behind Stairs –
Cracking to blockwork joints

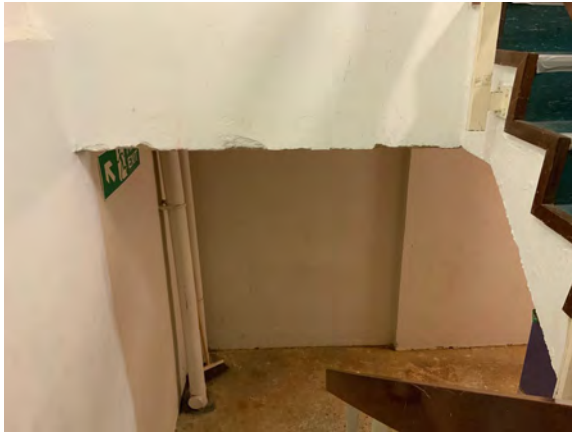
P98 Auditorium Lobby – Access panel inset into soffit

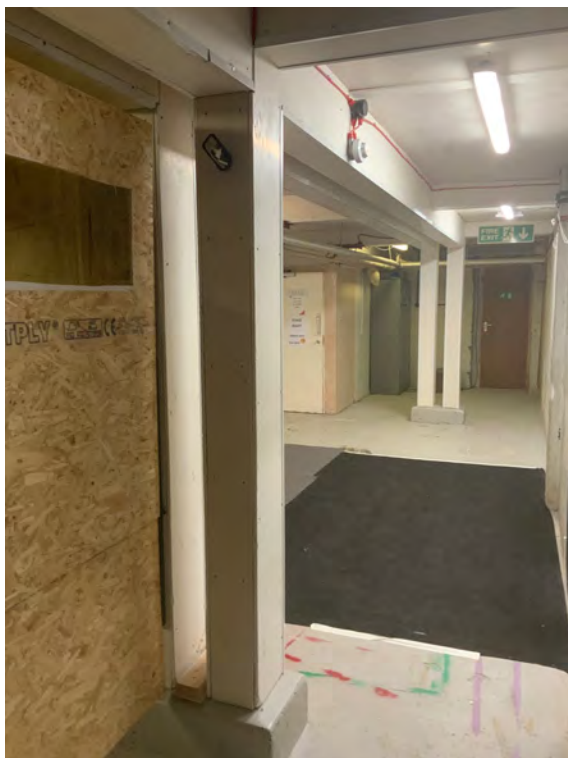
P112 Basement Store 1 – Front wall

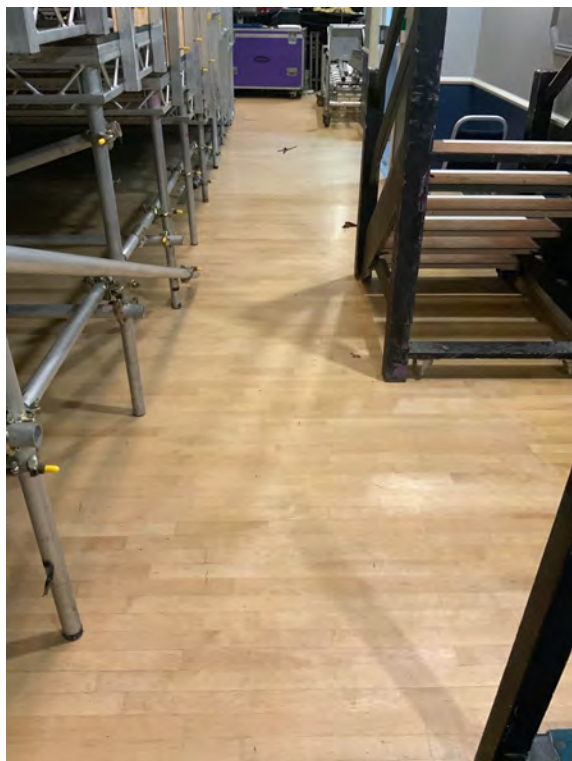
P116 Dance Studio - Flooring

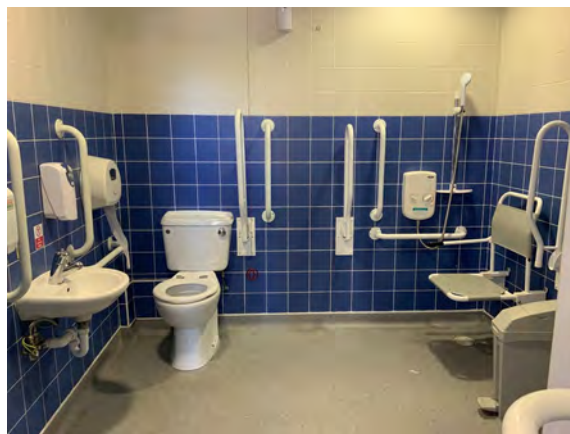
P165 First floor accessible toilet

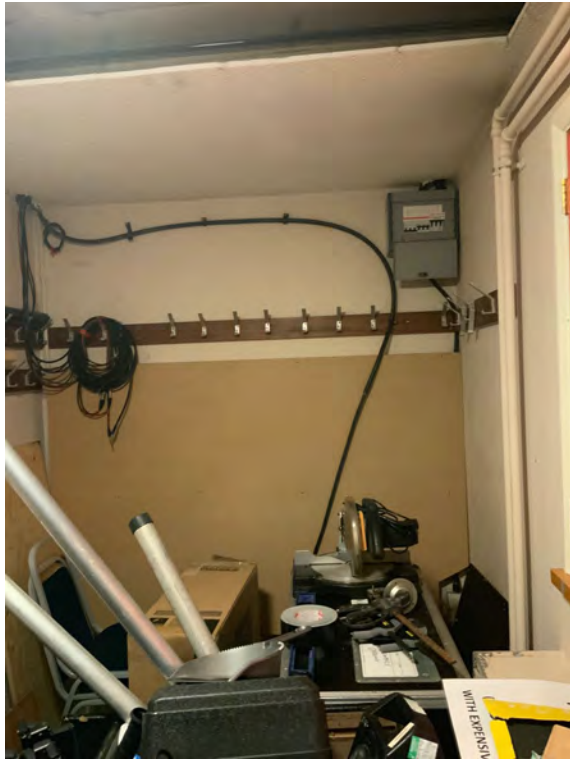
P174 RVS - Main dining room electrics

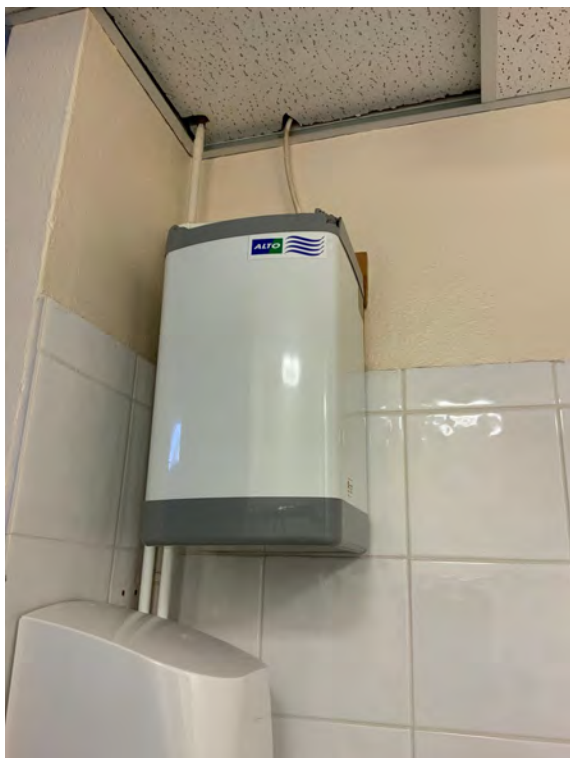
P184 Boiler room – Five boilers

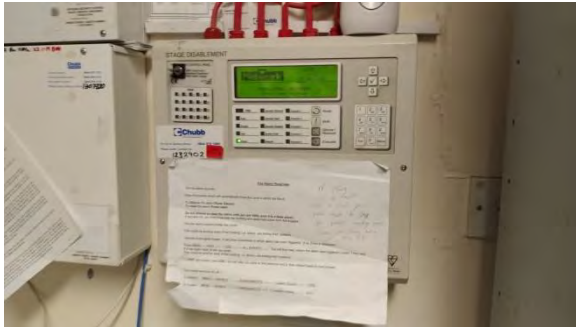
6.7 FIRE ALARM SYSTEM

The existing fire alarm and detection system features a Menvier MX4000 analogue addressable fire alarm panel with additional keyable switch to isolate devices during performances. The panel is located in the main Office behind reception, but there is a repeater panel near the café that is visible through the front windows.

Although the system is a more modern analogue addressable type, bells are used throughout rather than sounders – this is often the case where the bells can be rung to signal purposes other than fire events, such as intermissions, or performance starting.

The property seems well provisioned with automatic detection devices throughout, although some of the cabling that can be seen has not been installed in compliance with the relevant standards. The cabling that has not been installed correctly has not, in places, been secured to the building fabric or containment correctly. As a consequence, there is an entanglement risk during a fire which would need to be addressed.

It would be recommended, given the anticipated nature of the works that require to be undertaken, that the fire alarm and detection system would be replaced with a similar, newer system.

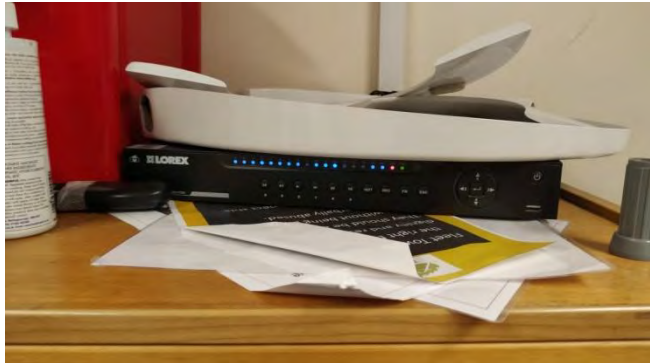
6.15 CLOSED CIRCUIT TELEVISION SYSTEM [CCTV]

A CCTV system has been installed within the last few years, covering relevant areas both in and around the theatre building. The cameras and NVR are manufactured by Lorex, a brand that is popular in America, but not very well serviced in the UK. We would expect this system to be removed and reinstated to facilitate the works. Cabling would be run as necessary if any of the cameras, or additional cameras are required, and the head end moved from the top of a cupboard into a new communications cabinet.

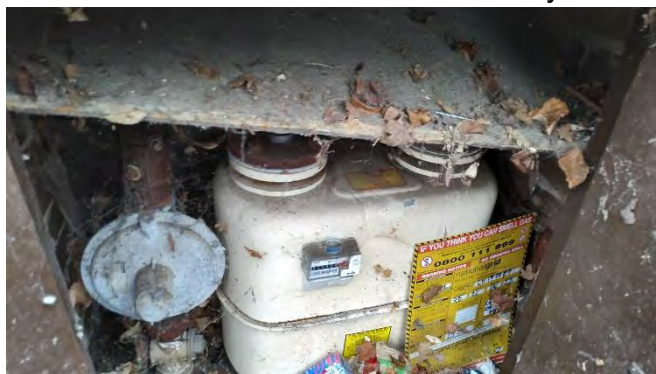
The gas meter cupboard outside the boiler plant room is within a floor mounted locked enclosure. The enclosure is dirty and litter strewn and would benefit from

being cleaned. In addition, the internal lining has broken loose from the fixings and is sitting on the pipework and the corrosion on the pipes indicates the cabinet is not weathertight. The cabinet would benefit from being replaced. The U65 gas meter appears to be in reasonable condition. The gas pipework
